Lincoln Hall Windows Research Report

A Case Study of Options for Treatment for Windows at Lincoln Hall, University Of Illinois, Urbana Champaign

Capital Development Board
Project Number 830-010-327

December 30, 2008
Revised March 05, 2009
Prepared by

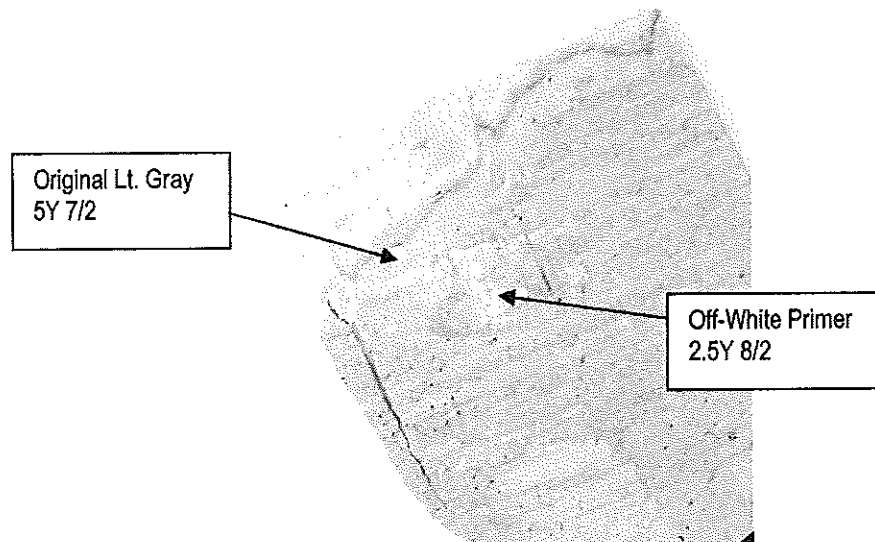
Photomicrograph Sample 1

Note: The original paint scheme appears to be a Light Gray (Munsell 5Y 7/2) over an Off-White (Munsell 2.5Y 8/2) primer. A Medium Gray (Munsell 5PB 6/1) immediately follows the Light Gray.
