COSMOPOLITAN CHRONICLE

True tales from the annals of history, archaeology, construction, and restoration of the Casa de Bandini and Cosmopolitan Hotel.
Old Town San Diego State Historic Park

Seismic Retrofit

Part 1

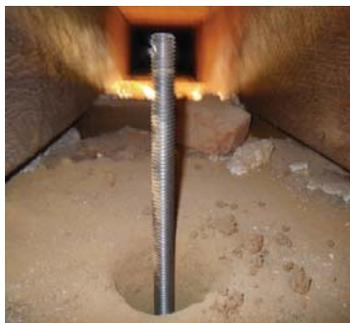
walls move back, the roof and second floors will still move in the original direction if not connected to the adobe walls below. This means that the building would actually be moving in two directions at the same time. An unacceptable degree of damage to both the adobe walls and wood framing could result unless adequate attachments between the two floors are made.

To connect the second story of the Cosmopolitan to the first, we are inserting 5/8" threaded stainless steel rods that are 60" long down the middle of the adobe walls. This is done by first coring holes in the upstairs wood floor to access the top of the adobe walls below. The wood plugs are numbered so they can be replaced in the original position when the job is complete. Two inch holes are then bored into the adobe, the rods are inserted and the holes are filled with a special adobe epoxy. The epoxy is slow cure to minimize
