COSMOPOLITAN CHRONICLE

True tales from the annals of history, archaeology, construction, and restoration of the Casa de Bandini and Cosmopolitan Hotel.
Old Town San Diego State Historic Park

If the Walls Could Talk.

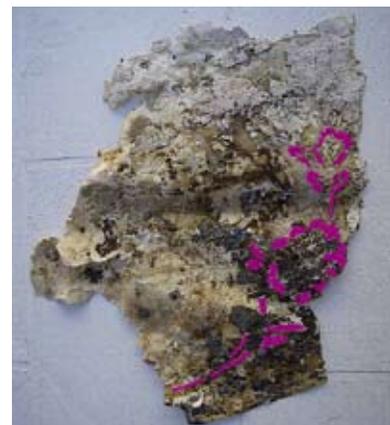
Although the floral pattern was faded a similar pattern was found that dates between the 1840s and 1880s. (The photo at the end of this article was enhanced to show the floral pattern.)

Archaeological project leader Niloufar Minovi recently recovered two pieces of wallpaper from room 104-B, which is located on the side facing Calhoun Street. The wallpaper was peeling off a three foot reveal. The reveal is the area on the sides of an opening. The whitewash over the wall paper was peeling off and it was possible to see a faint pattern of green flowers and leaves. A black dusty layer was also noticed in between the whitewash and the floral pattern.

The wallpaper is very brittle, the floral design is almost gone, the original colors are gone with the exception of some faint light green and it's very difficult to make out the pattern. A professional curator will have to do the final curation and stabilization. In the meantime, we archaeologists are committed to giving "first aid" to the artifacts, to protect them and avoid further damage. In our role of "first responders", we dusted the wallpaper with a soft brush, photographed it, and stored it in between acid free tissue paper, acid free cardboard, and inside an archival plastic box to keep it away from light and moisture.
