Lessons Learned in Fire Recovery and Restoration

The San Dieguito River Park and the Witch Fire of 2007

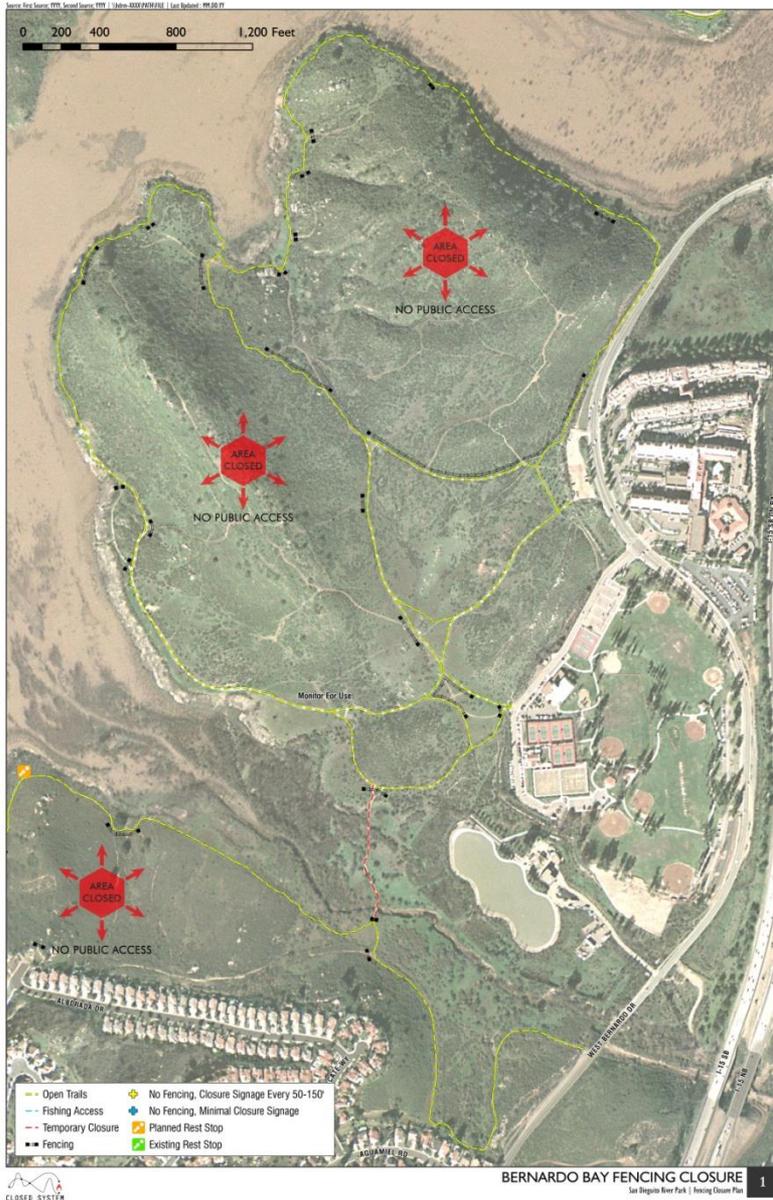
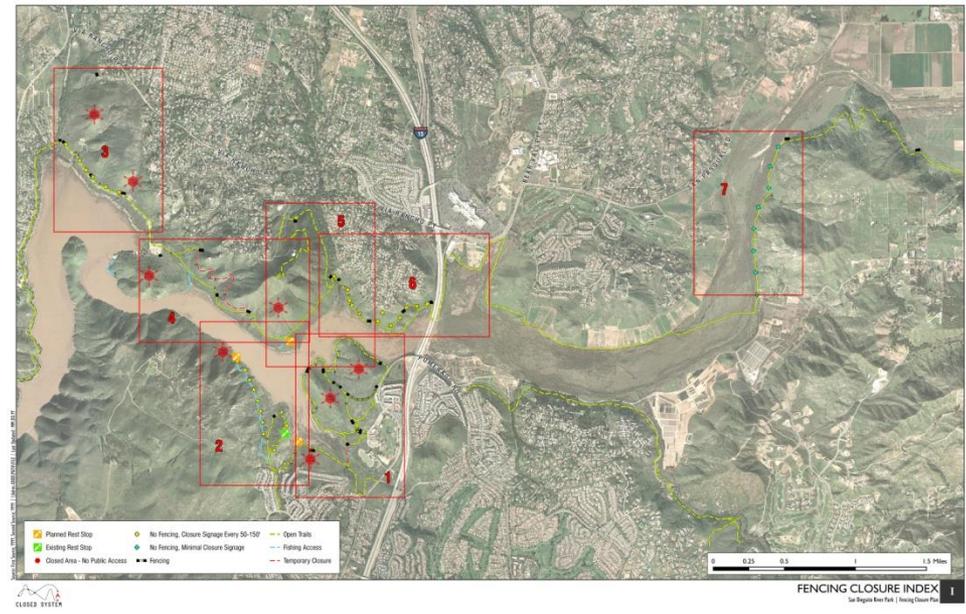
Typical mapping used to identify initial management strategies. Park Rangers implemented projects with CDF inmate crews and Urban Corps of San Diego.

Maps produced by a volunteer!

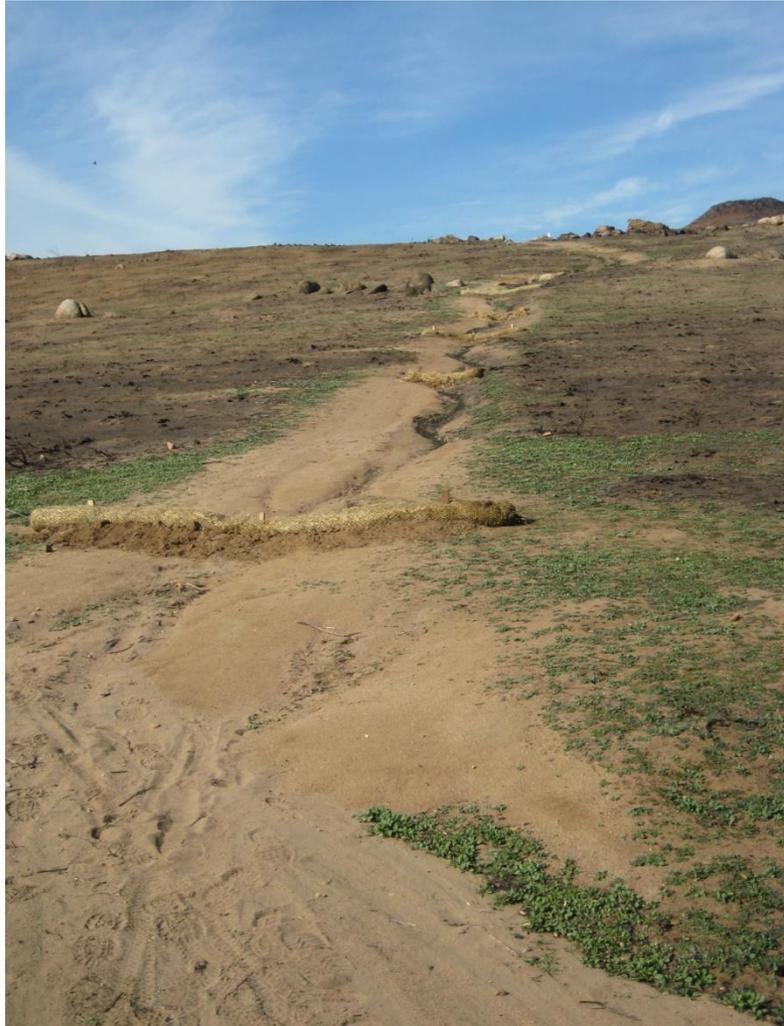
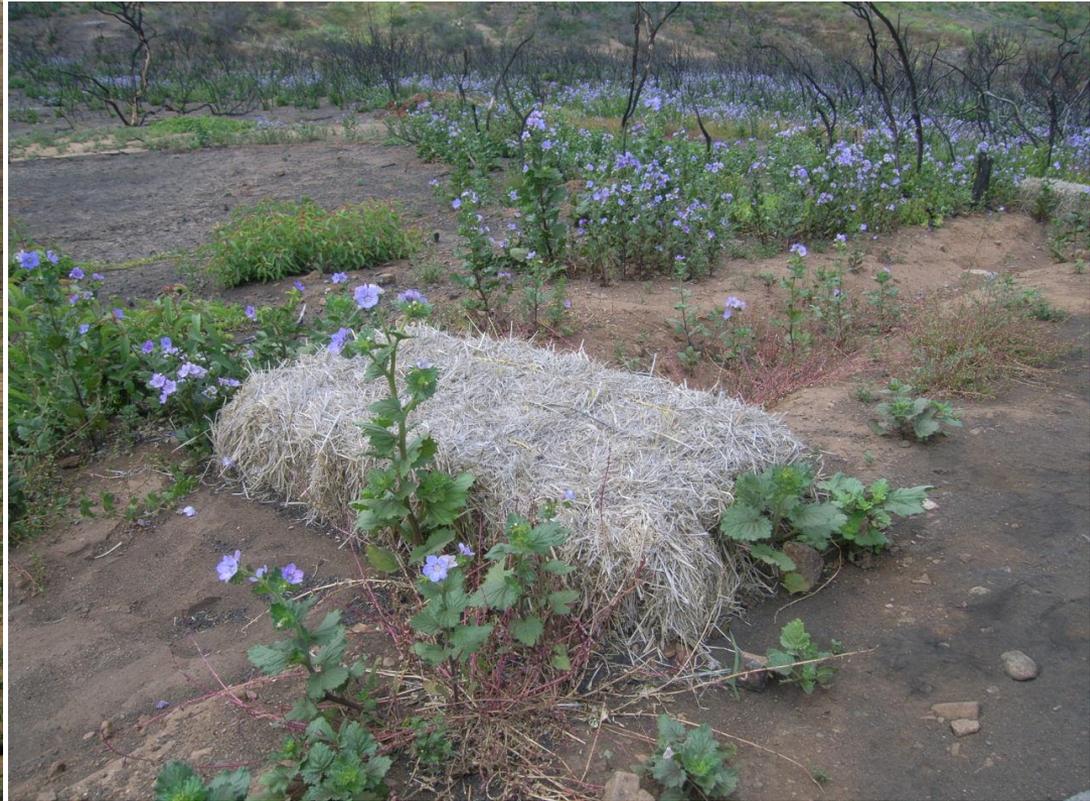
Erosion Control

- Drainages that intersected the trail were stabilized using weed free straw wattles and bales, plants, rock, and jute netting.

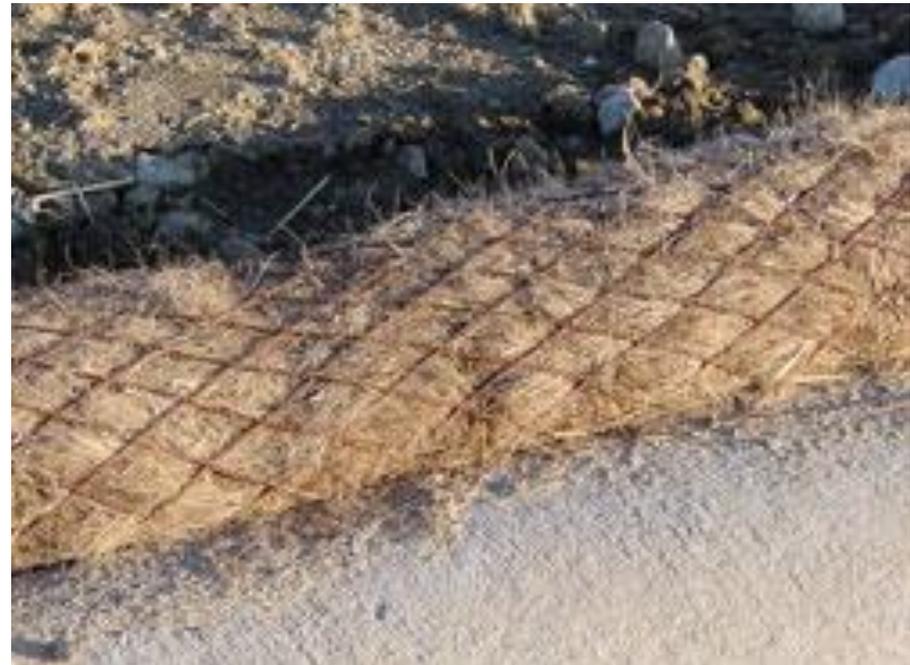
Better Alternative Wattles

- Biodegradable sediment control products made from natural fibers, including coir (coconut fiber)
- Wrapped in strong coir twine, netting has 2 in. x 2 in openings that are designed to avoid trapping or injuring wildlife.

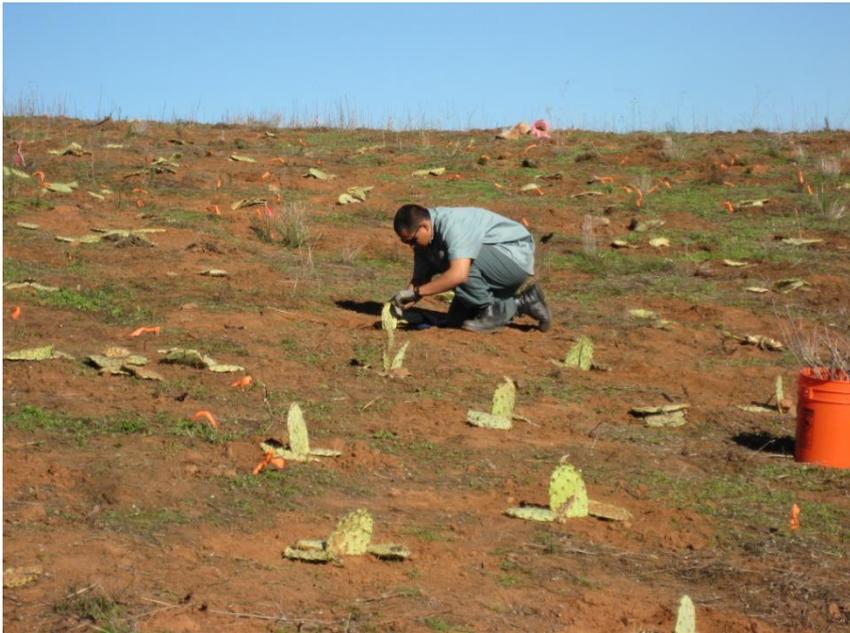
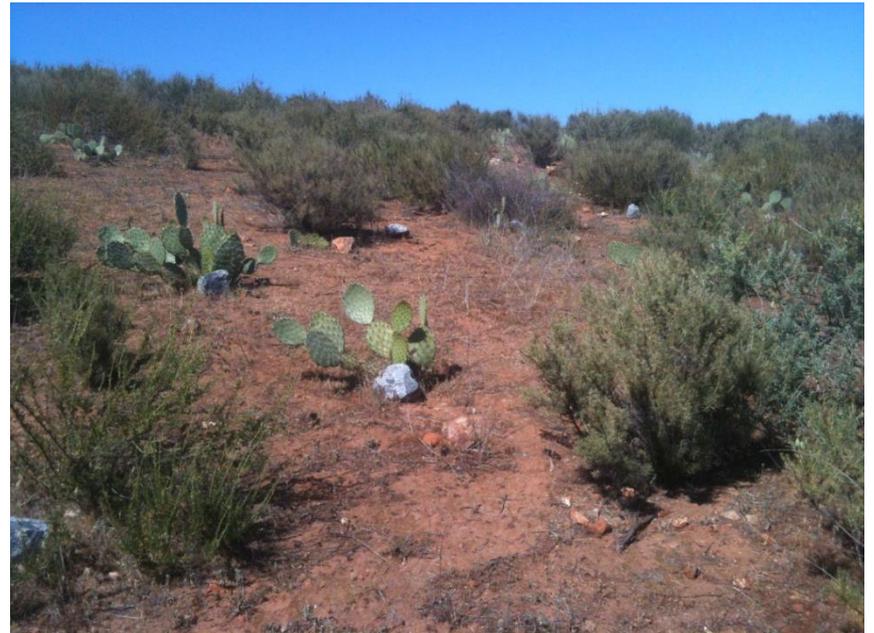
Restoration

- Winter 2008

- Spring 2013

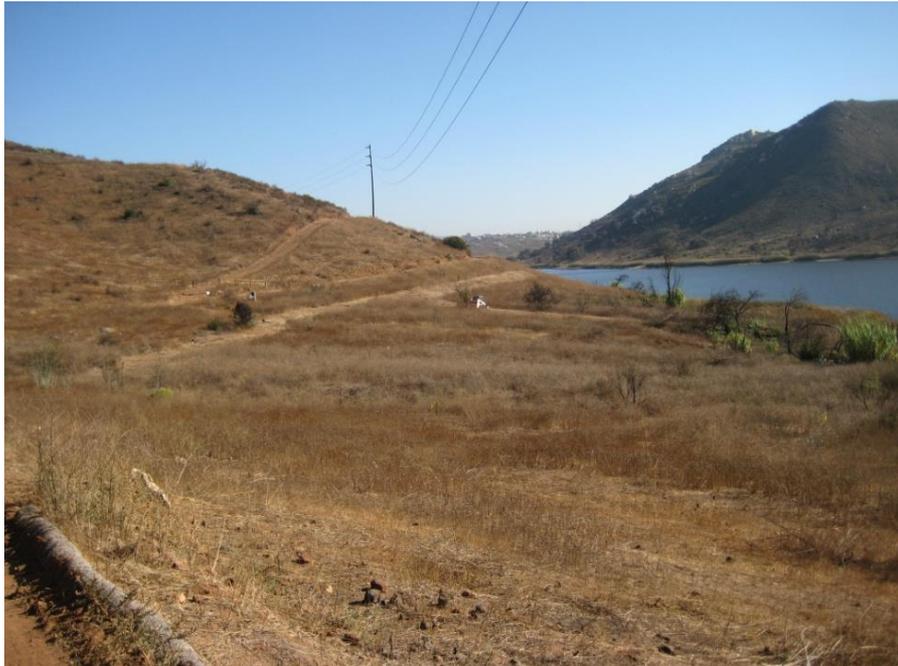
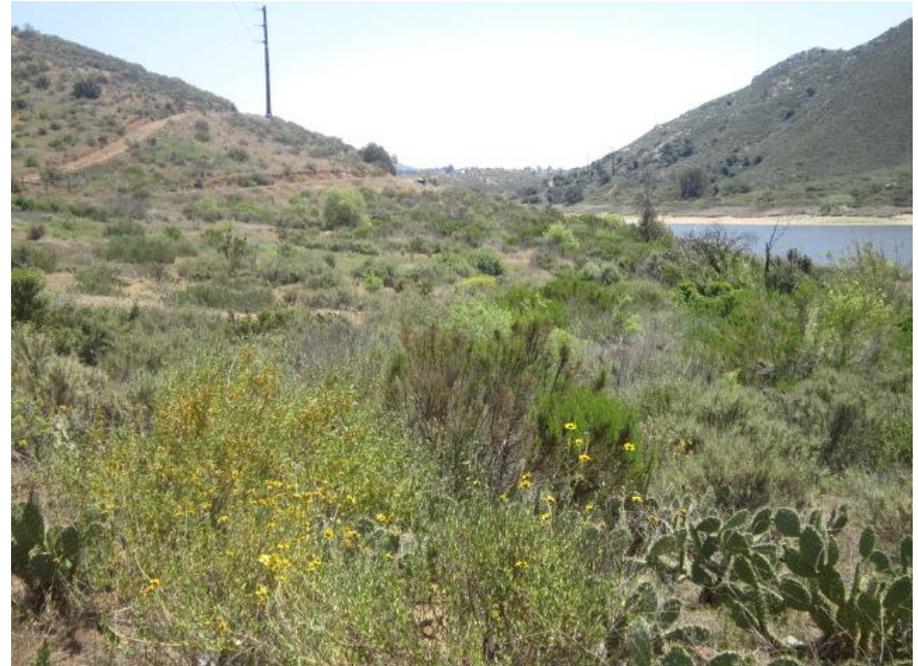
Habitat Restoration

- Post Fire

- Post Restoration
