**RODEO GROUNDS ROAD
RESTORATION AND REVEGETATION
PLAN**

**Prepared by:
Suzanne Goode
Nat Cox
CA Department of Parks and Recreation
Angeles District
1925 Las Virgenes Road
Calabasas, CA 91302**

August 2006

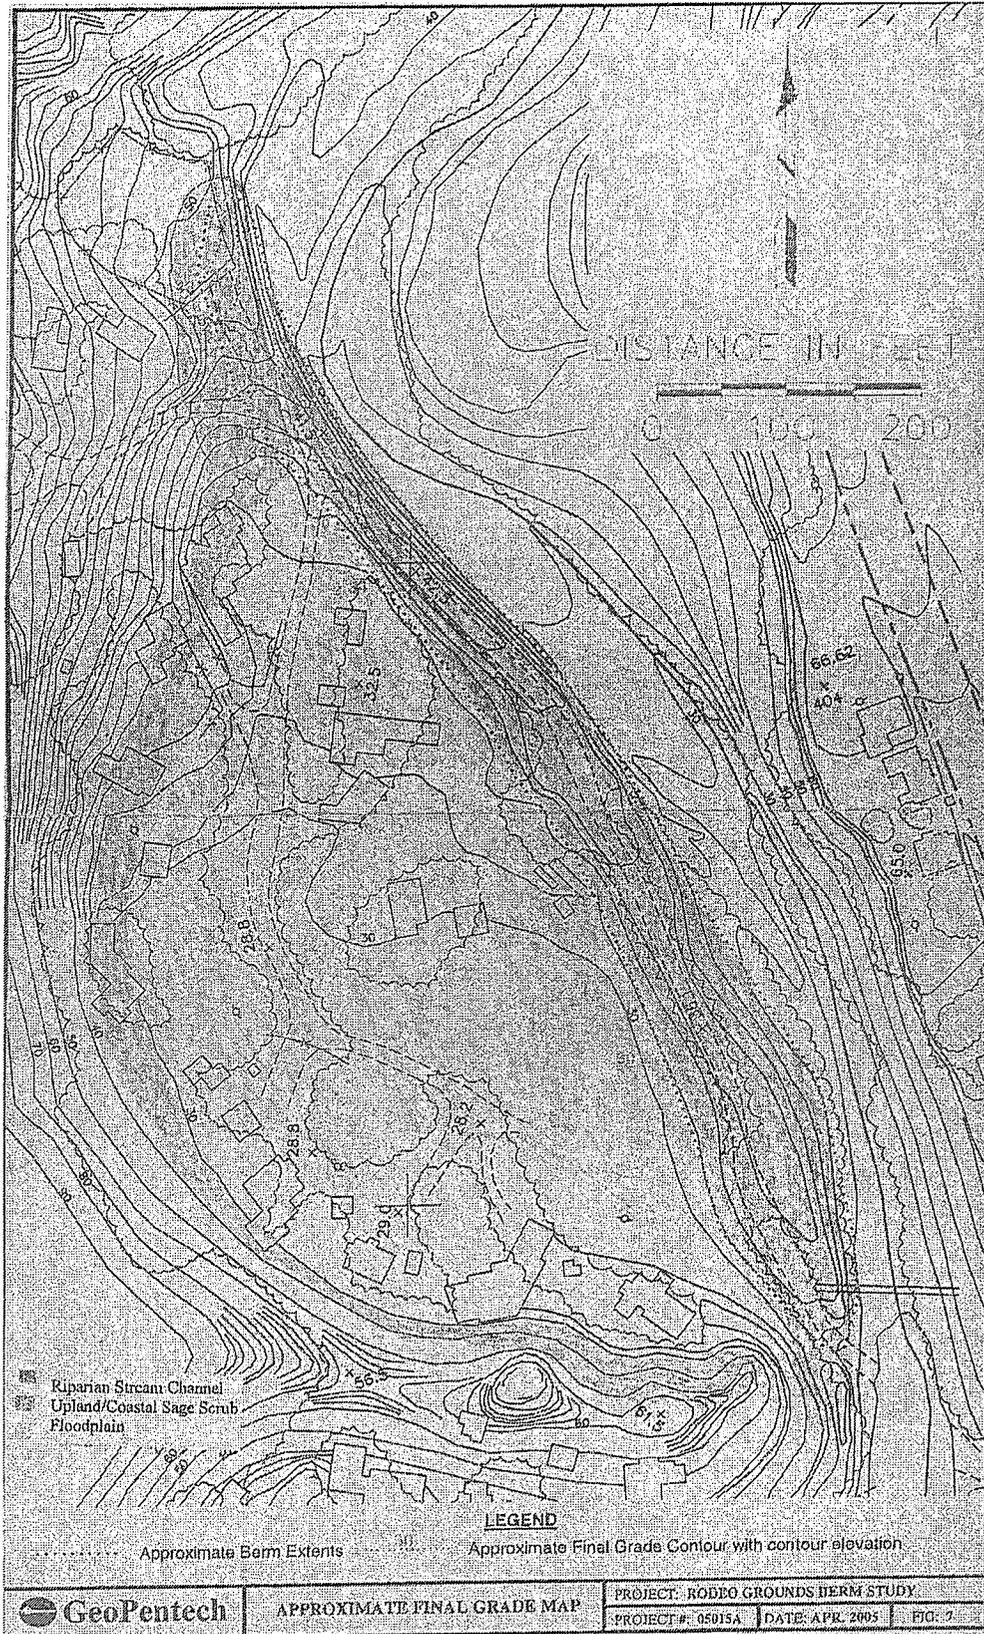
Figure 1. Rodeo Grounds Berm Project Revegetation and Restoration Project

This project is located approximately 2,500 feet upstream from the ocean, bounded by the present creek channel on the east, and a natural hillslope on the west and southwest. The project area includes the 1.8 acre berm which will be removed down to natural creek bed level, as well as the surrounding floodplain which has experienced disturbance from a variety of development associated with the residential land uses. The total project area encompasses approximately 12.4 acres, where all exotic ornamental vegetation will be removed during excavation and structure removal.

The revegetation and restoration effort will focus on planting trees along the toe of the slope to provide additional stabilization. Willow and mulefat cuttings and seeds will be directed to the former berm footprint. The disturbed floodplain area which will be used during the excavation process for truck access and stockpiling materials will be de-compacted and at least 6 acres hydroseeded with a seed mix appropriate to the site.

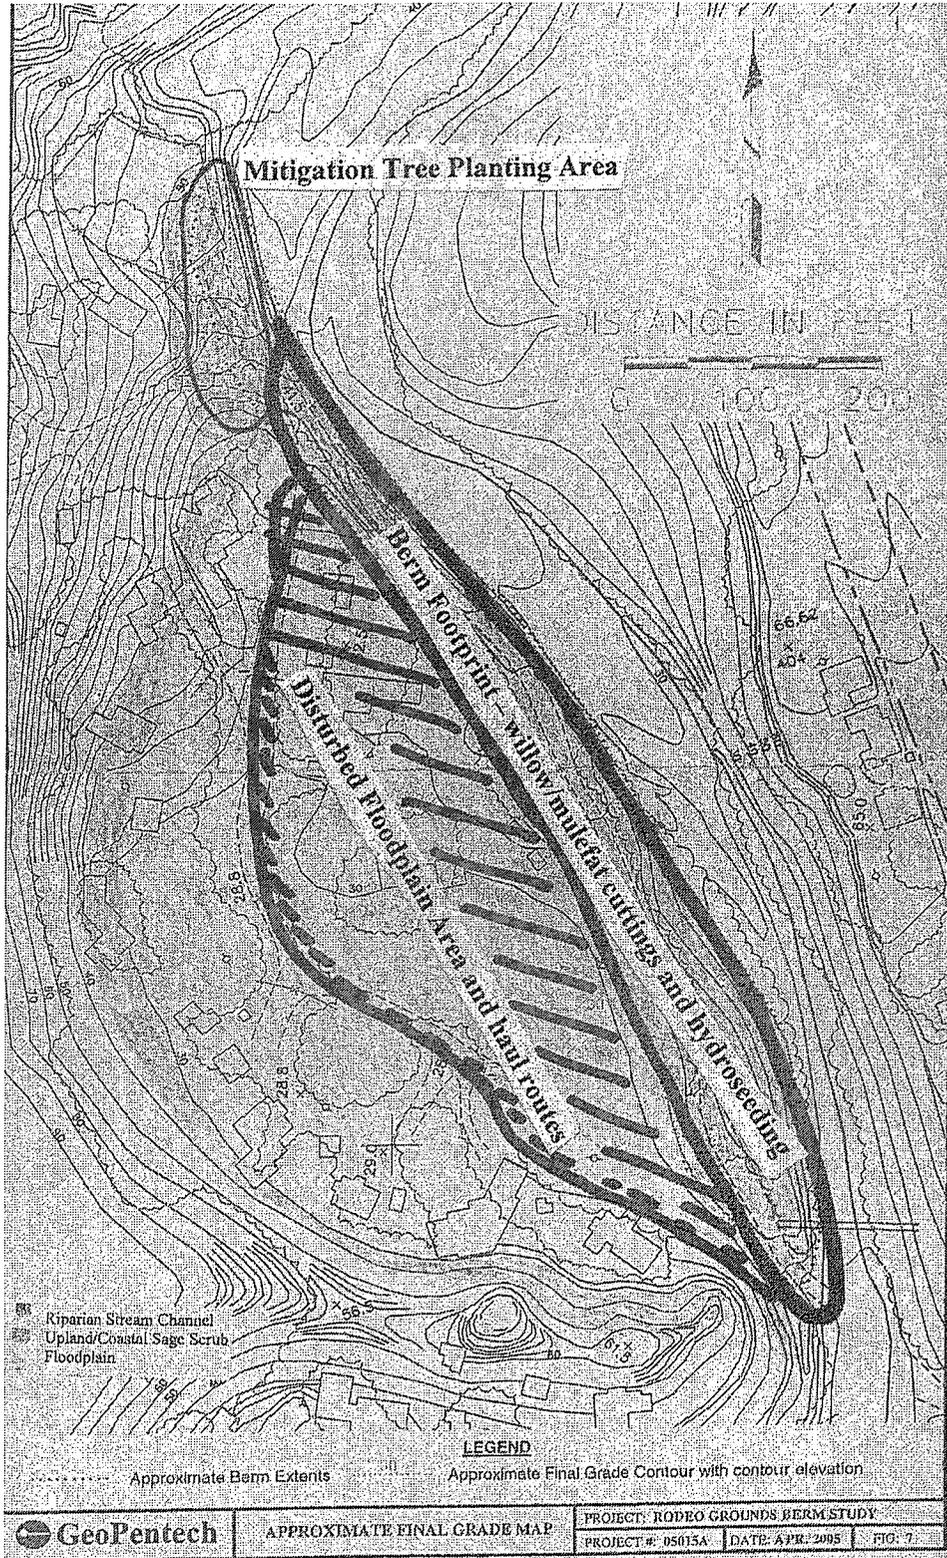
Figure 2. Rodeo Grounds Berm Replanting Plan

A plan that depicts the planting areas is found in Figure 2.
