## Chapter 8. Accessible Trail Design

As outlined in Chapter 5, *Principles of Trail Layout and Design*, general trail layout and design principles are applied to trails for all user groups. However, the trails for each group have specific and unique design requirements to ensure they provide for safe enjoyment, protect the resources, and are sustainable. Meeting these requirements is one of the most challenging tasks faced by a designer. To every extent possible, all trails should have the highest level of accessibility. This chapter addresses the design criteria for “accessible” trails and trailheads, but does not include outdoor recreation routes, beach routes, shared use paths, public right-of-ways, or accessible routes for which separate guidelines would apply. This chapter also presents design and construction strategies for accessible trails developed by the Department.

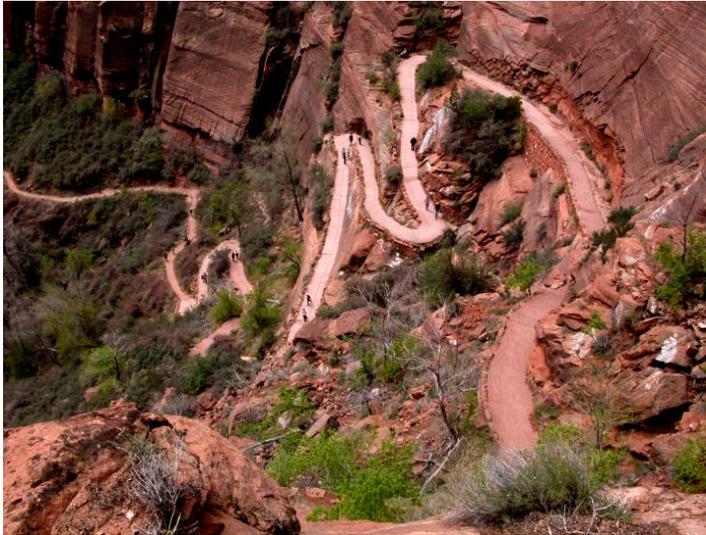
**Photo 8.1 - Infeasible Terrain**

Compliance is not practicable due to terrain. An example of terrain that is infeasible to meet accessibility guidelines is a coastal descent trail where the elevation difference from the start to end points and a limited landbase for layout require the use of steeper grades or trail structures such as steps. These conditions also exist in areas where cliffs or steep terrain result in a substantial elevation difference between start and end points and a limited landbase for layout. In these circumstances, substantial control points prohibit the linear trail grade needed to comply with the accessibility guidelines and may require the use of trail structures that will serve as barriers to accessibility. (See Photo 8.1.)

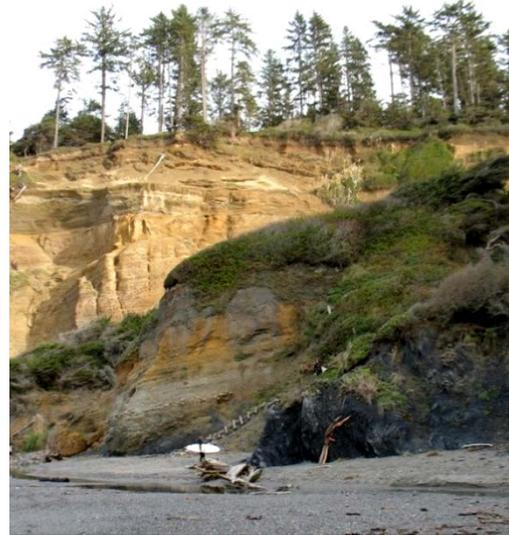
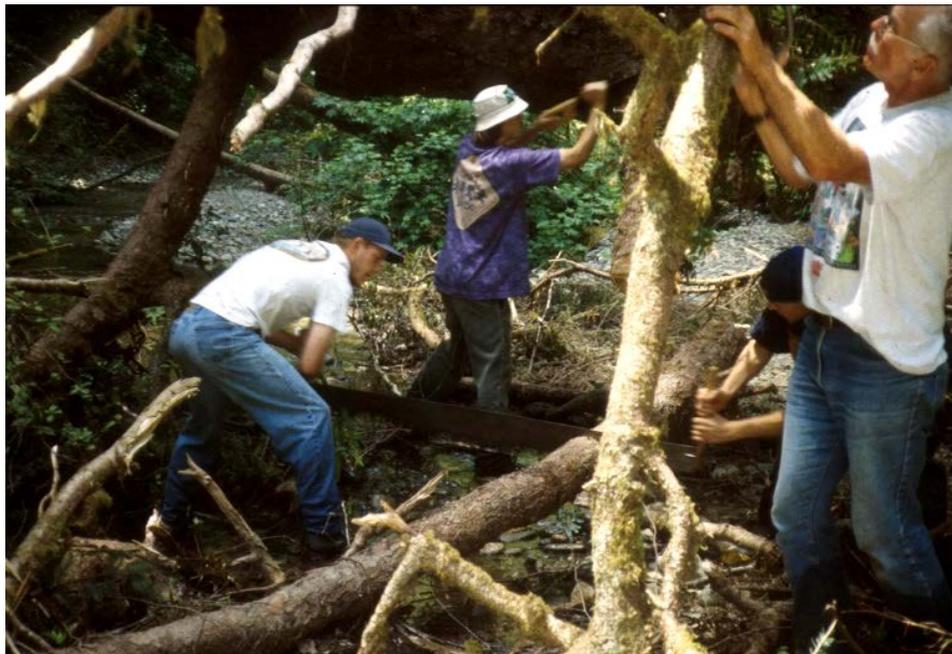
**Photo 8.2 - Unskilled Volunteers Clearing a Trail**

Compliance cannot be accomplished with the prevailing construction practices. An example of a construction practice that does not allow compliance is the exclusive use of unskilled volunteer labor to perform trail construction and maintenance. This labor force may not have the knowledge, skills, tools, or equipment to construct or reconstruct trails to meet the standards. (See Photo 8.2.)

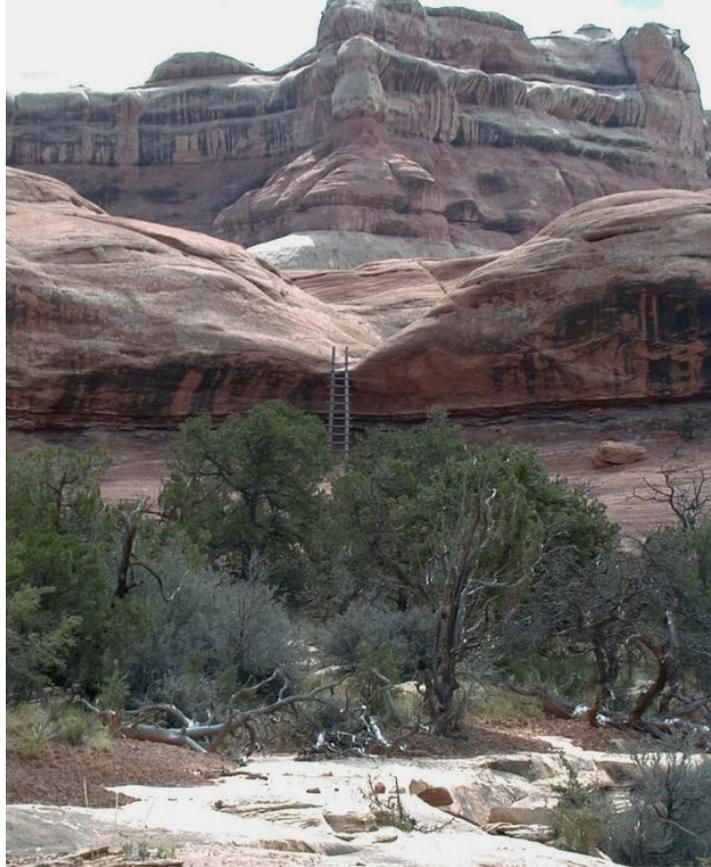
***Photo 8.3 - Trail Experience That Would Be Altered if Made Accessible***

Compliance will fundamentally alter the function or purpose of the facility or the setting. An example of altering the setting includes redesign and reconstruction of a trail designed for a primitive outdoor experience, such as access into a wilderness area or natural preserve. These trails are often narrow, have minimal structures, and provide the user with close contact to the surrounding environment. Widening and improving the trail tread and building additional structures to comply with accessibility guidelines will substantially alter the user's experience. (See Photo 8.3.)

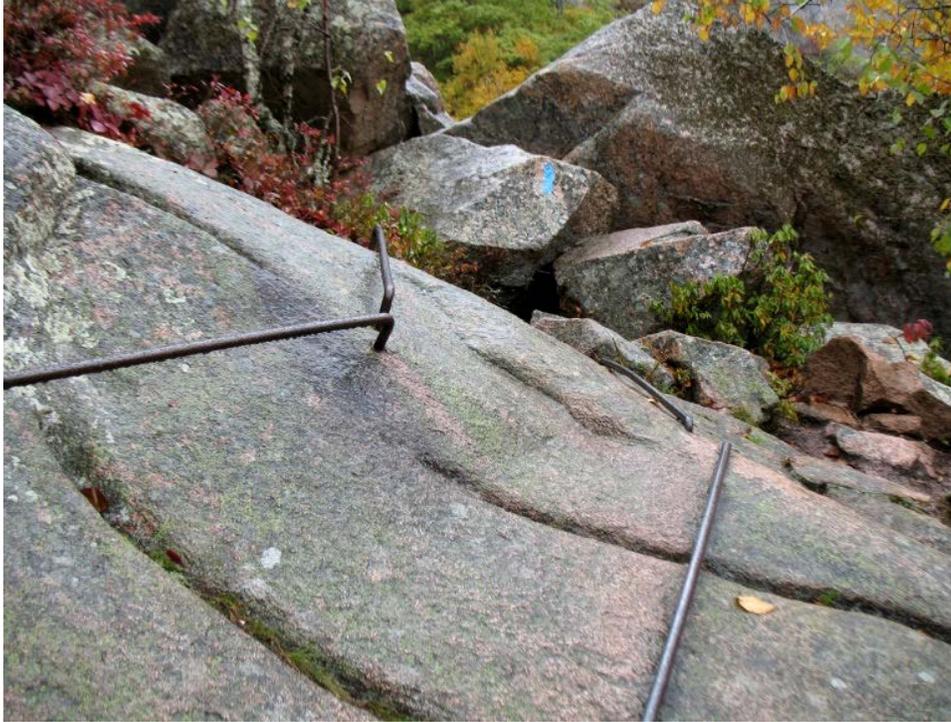
**Photo 8.4 - Iron Ladder used to Assist Hikers Ascending a Rock Face**

Another example of compliance that alters the purpose of the trail includes redesign or reconstruction of a trail that was intended to provide users with a rugged outdoor experience, such as a slick rock trail route in the southwest, boulder scrambling on the Appalachian Trail, or iron ladders ascending up rock faces in Acadia National Park. These trails are intended to provide visceral contact and experience with the environment. To comply with accessibility guidelines would require substantial widening, grade reduction, tread improvement, and trail structures. Again, the user experience would be altered or lost as a result of these changes. (See Photo 8.4.)

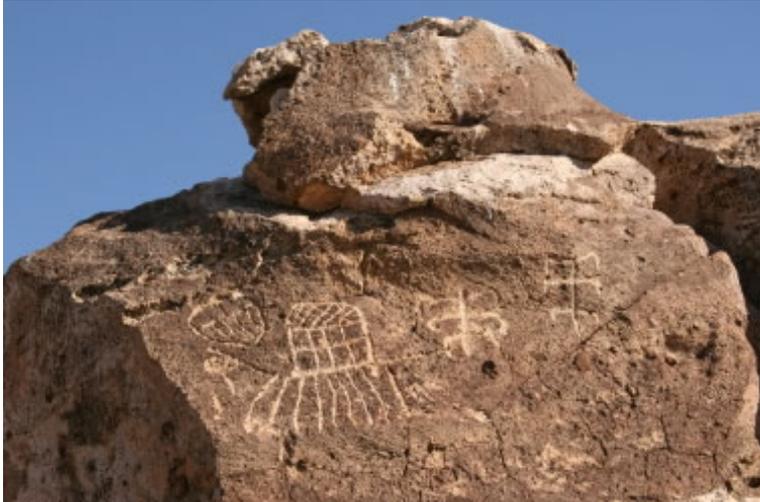
**Photo 8.5 - Cultural Features That Could Be Disturbed if Trail is Made Accessible**

Examples of potential law violations include disturbance, removal, or alteration of pre-historic and historic cultural sites necessary to comply with accessibility standards. These sites include Native American middens, sacred sites, and ceremonial sites, and Euro American buildings, structures, historic sites, and religious sites. Typically these sites are listed or eligible for listing on national or state registers for historic places. (See Photo 8.5.)

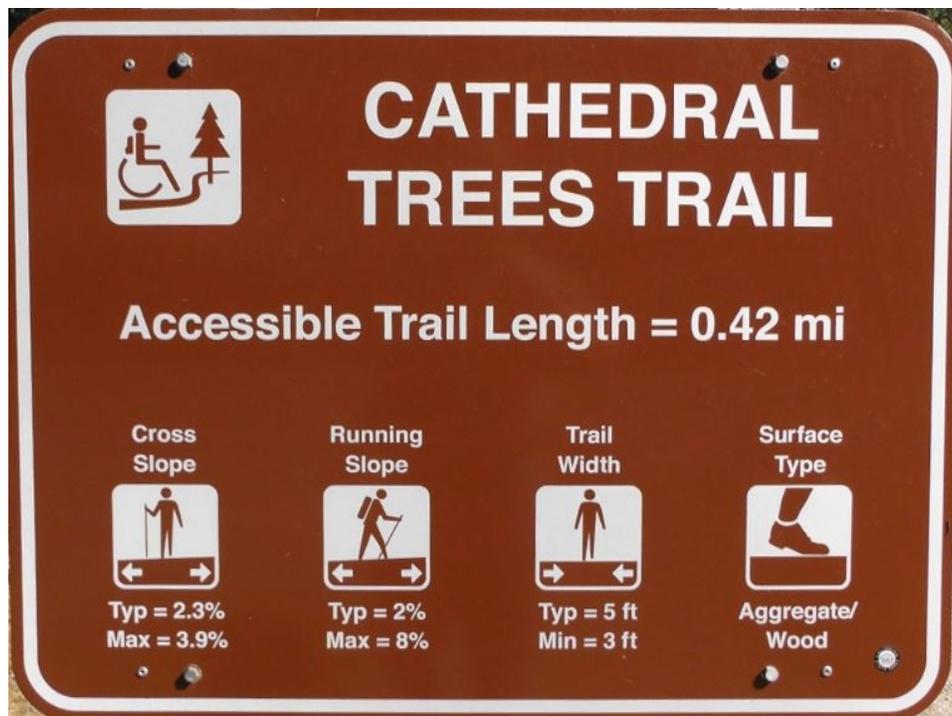
**Photo 8.7 - Example of an Accessible Trail Sign**

New trail information signs are required at trailheads on newly constructed and altered trails designed for use by pedestrians to comply with the applicable technical requirements for trailhead signs, regardless of whether the trail is accessible. Contact the Department's Accessibility Section for additional information on accessible trail signage. (See Photo 8.7.)

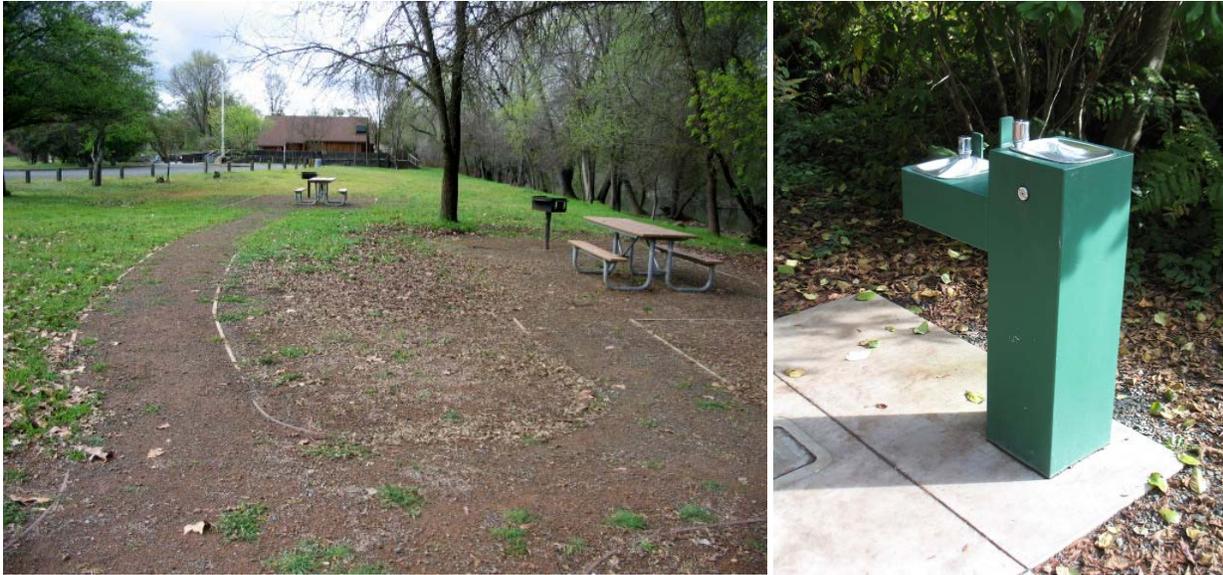
**Photo 8.8 - Examples of Accessible Trailhead Features**

When outdoor, constructed features are provided at trailheads, at least 20% but not less than one of each feature shall be accessible. (See Photo 8.8.)

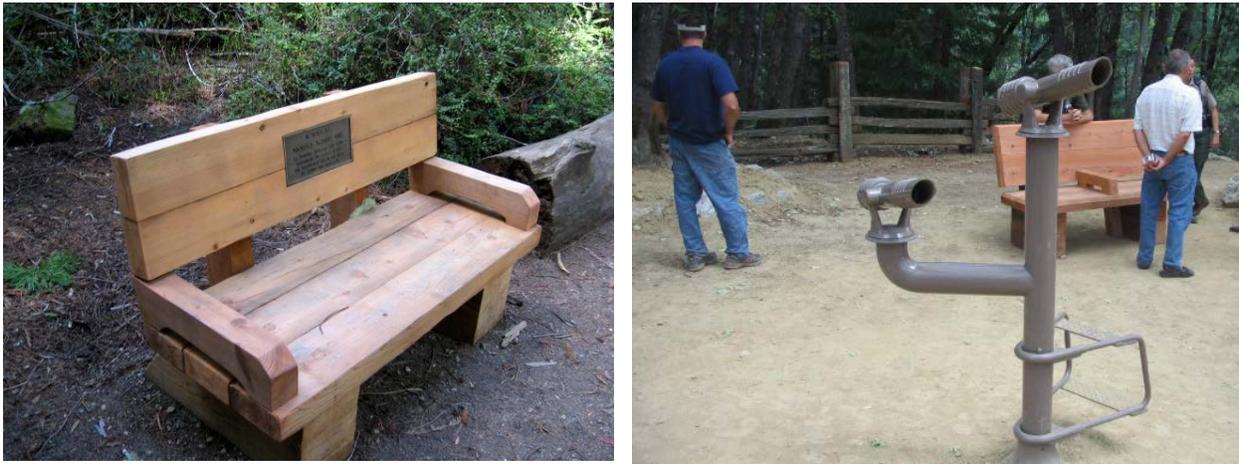
**Photo 8.9 - Examples of Accessible Trailside Features**

When outdoor constructed features are provided along a trail, at least 20% but not less than one of each feature shall be accessible. For example, if ten benches are located along a trail, then at least two of those benches need to be accessible. If one bench is located along a trail, then that bench needs to be accessible. (See Photo 8.9.)

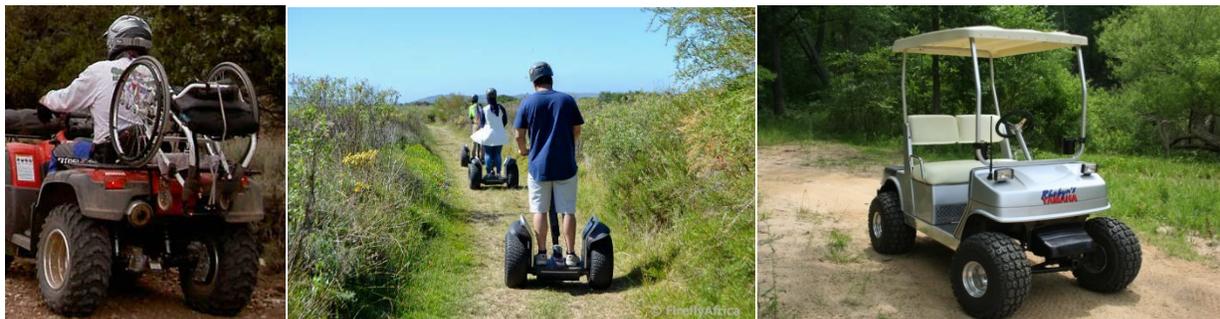
**Photo 8.10 - Examples of OPDMDs**

The U.S. Department of Justice amended the language in Title 2 of the Americans with Disabilities Act to include another category of mobility aids known as Other Power Driven Mobility Devices (OPDMD). (See Photo 8.10.) OPDMDs are any of a large range of devices powered by batteries, fuel, or other engines, whether or not designed solely for use by individuals with mobility impairments, that are used by individuals with mobility impairments for the purpose of locomotion, including golf carts, bicycles, electronic personal assistance mobility devices, or any mobility aid designed to operate in areas without defined pedestrian routes.

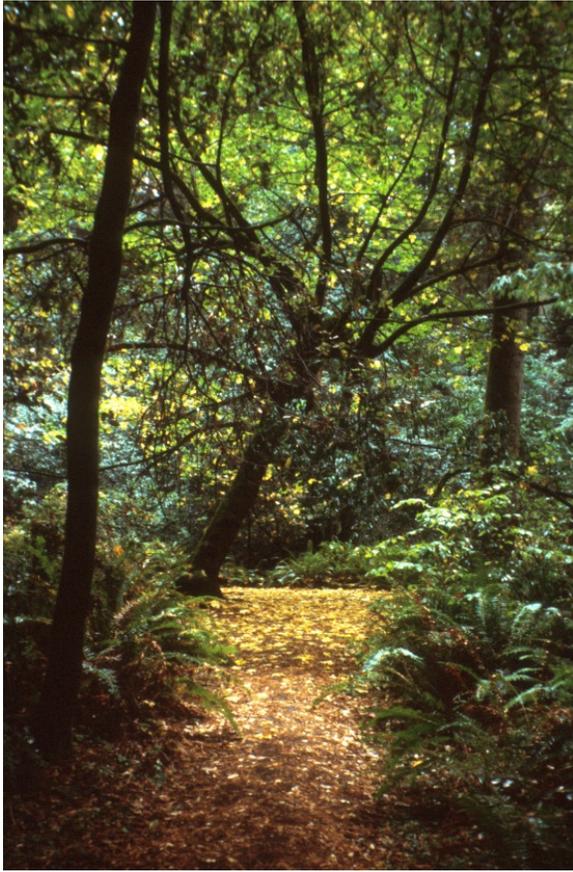
***Photo 8.11 - Accessible Trails that Provide an Intimate Experience***

Users with disabilities want the same outdoor experience as other trail users. Highly developed asphalt or concrete trails located on flat ground behind the visitor center or in the campground may be desirable for some users with a disability, however, these types of accessible trails are designed and constructed using traditional methods of the “built environment”. They often do not provide access to the primary resources that visitors are seeking. The building materials, colors, textures, and defined edges of these paths contrast with the surrounding environment and perceptually separate the user from that environment. The challenge for the designer is to develop an accessible trail that provides intimate access to high quality resources in a fashion that is seamless with the environment. (See Photo 8.11.)

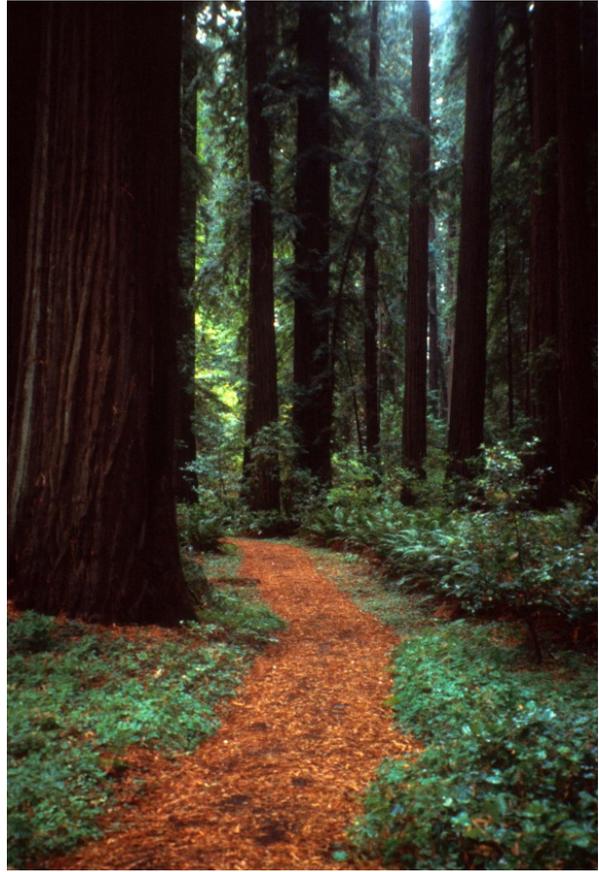
***Photo 8.12 - Wheelchair Pulled to the Outside of the Trail***

The common hospital-style wheelchair provided by health care organizations to people with mobility impairments is very functional in the built environment, but limited in the outdoor environment. These chairs have narrow, smooth tires that limit their flotation and traction on soft, smooth, or slick surfaces. Their suspension consists of a single axle for the rear wheels and small castors in front. This suspension design causes the chair to pull toward the downhill side of the trail, and the user must correct this pull by turning the chair toward the upper side of the trail. Once it reaches the upper side, the chair straightens until it is gradually pulled to the downhill side of the trail and the

process begins again. This zigzag motion requires more trail width and more effort from the user. (See Photo 8.12.)

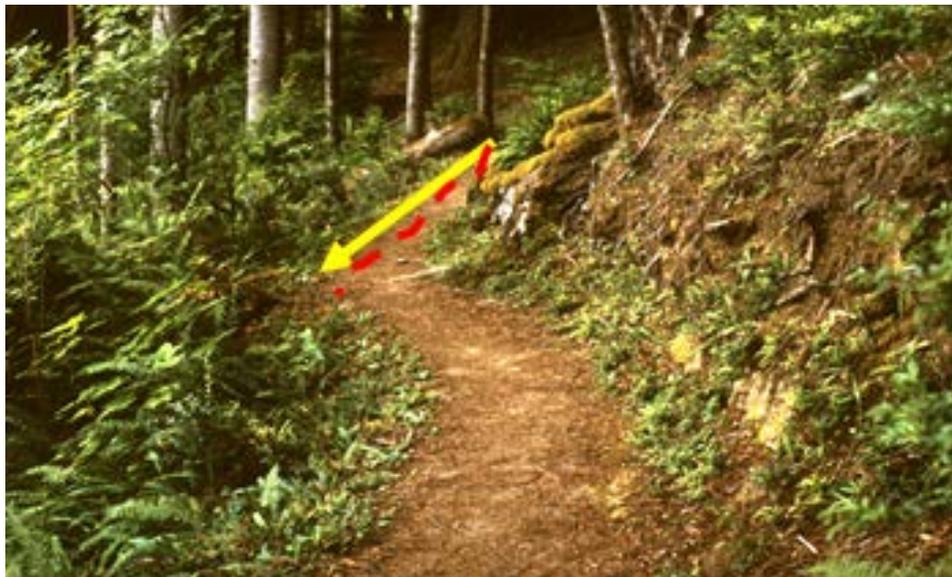
**Photo 8.13 - Combination of Linear Grade, Cross Slope, and Change of Direction**

When the trail combines linear grade, cross slope, and a change in direction, the wheelchair is pulled even more to the outside edge of the trail. The user in the wheelchair has to keep it from drifting to the edge of the trail. (See Photo 8.13.) This condition can be offset by widening the trail tread, improving the trail surface, or installing edge protection.

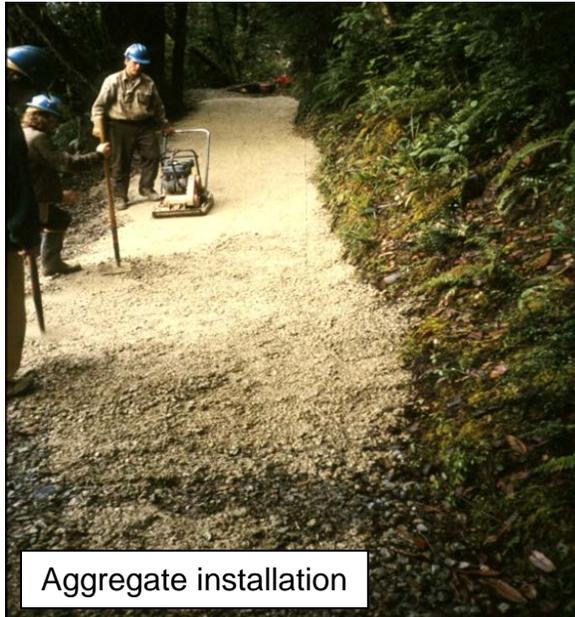
**Photo 8.16 - Installing Crushed Aggregate with Native Soil to Harden Trail Tread**

Trail segments with minor bench and surface deficiencies are reconstructed to obtain a uniform linear grade and outslope. Locations where the tread surface fails to meet firmness and stability requirements are augmented with trail hardening techniques that produce a firm and stable trail surface that closely matches the color and texture of the native soils. The material should also provide a good coefficient of friction during wet conditions, as well as when the trail is littered with organic material. It should allow water to percolate through and evaporate off to minimize seasonal resource impacts. The material should be simple to install, long lasting, sustainable, and easy to maintain. (See Photo 8.16.)

Aggregate installation

Completed trail surface

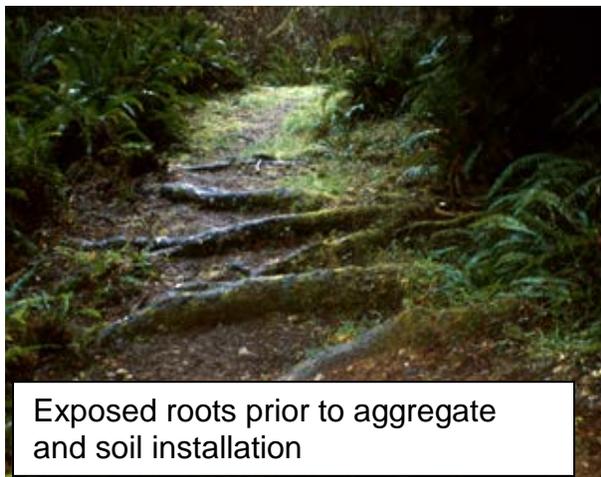
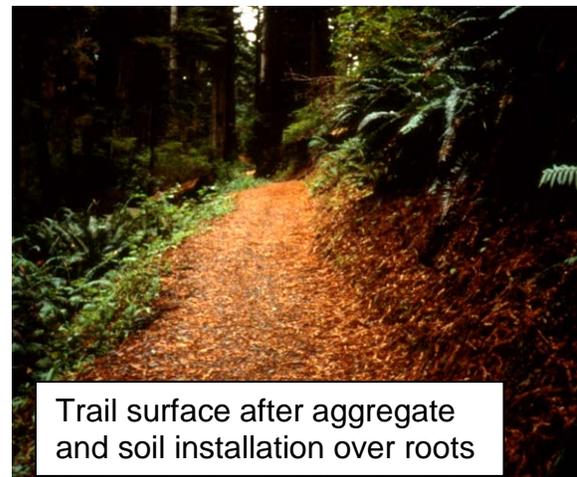
**Photo 8.17 - Bridging Over Roots with Crushed Aggregate and Native Soil**

Remove rocks and small roots from the tread surface to provide a uniform and smooth trail tread. Large roots are covered or capped with crushed rock and native soil to bridge over the obstacles ("turnpiked"). (See Photo 8.17.)

Exposed roots prior to aggregate and soil installation

Trail surface after aggregate and soil installation over roots

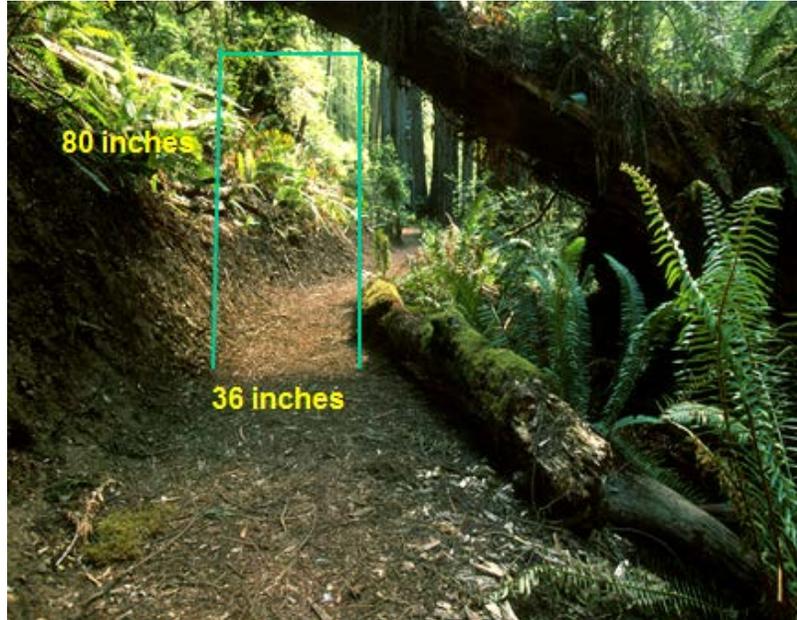
***Photo 8.18 - Aligning Trail to Provide Required Overhead Clearance***

impairment along the trail. When possible, edges are elevated to allow sheet drainage to flow underneath the edging. The trail should be rerouted when a significant number of downed trees are encountered, if a route can be identified that still provides the user with an up-close, tactile experience wherever possible. (See Photo 8.18.)

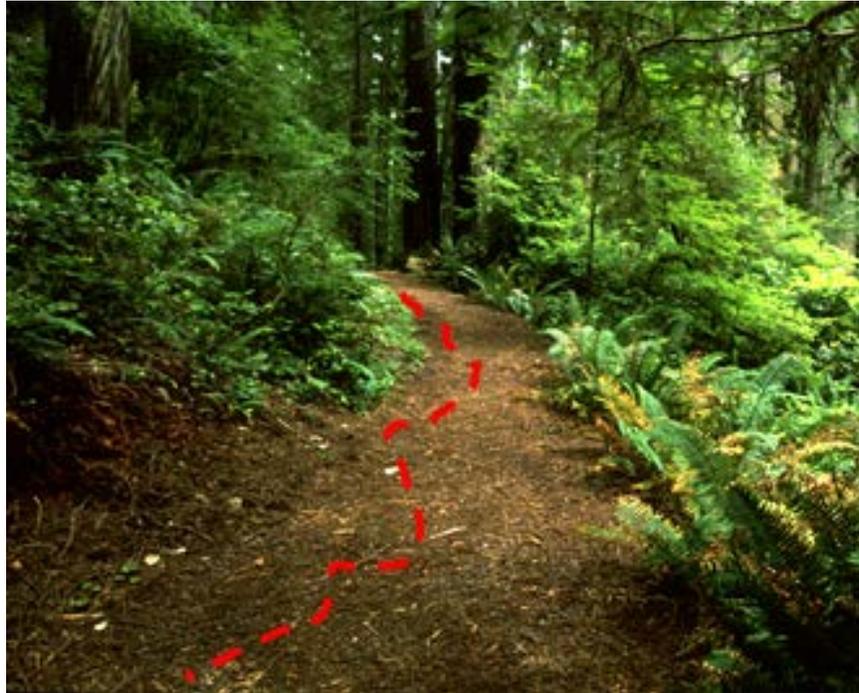
**Photo 8.19 - Example of Widening and Hardening Trail Tread**

Where the linear grade is steep (8% to 10%) and the cross slope is 4 to 5%, consider widening the trail between 48 and 60 inches where possible, and hardening the trail surface to increase the coefficient of friction. (See Photo 8.19.)

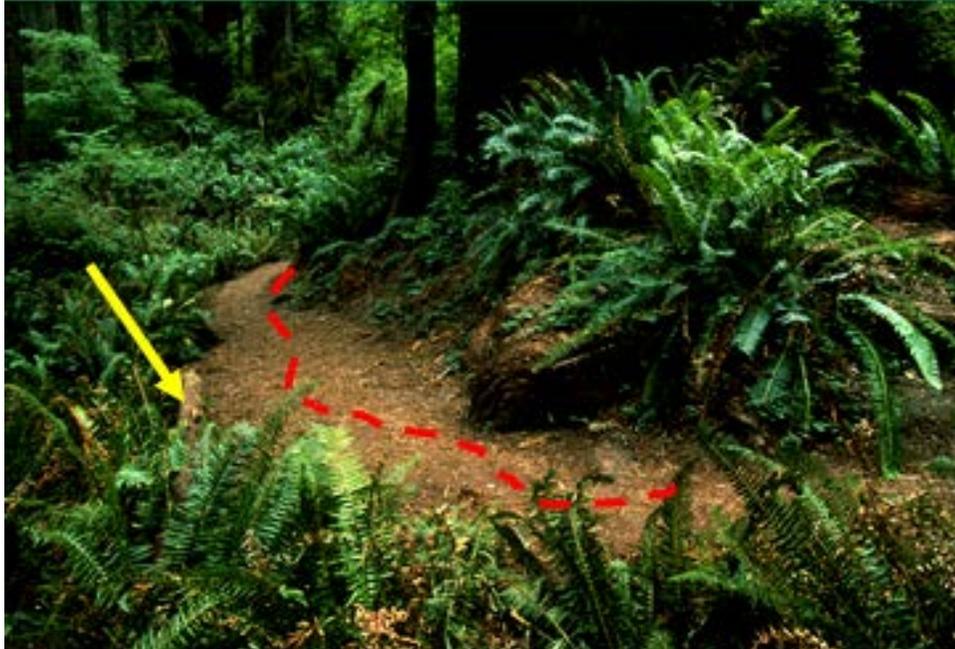
**Photo 8.20 - Installing Edge Protection on Outside of Turn**

Consider widening the trail tread to between 48 and 60 inches where possible; improving the tread surface by using a hardening technique to increase the coefficient of friction; and installing edge protection along the radius of the turn if site conditions dictate. (See Photo 8.20.)

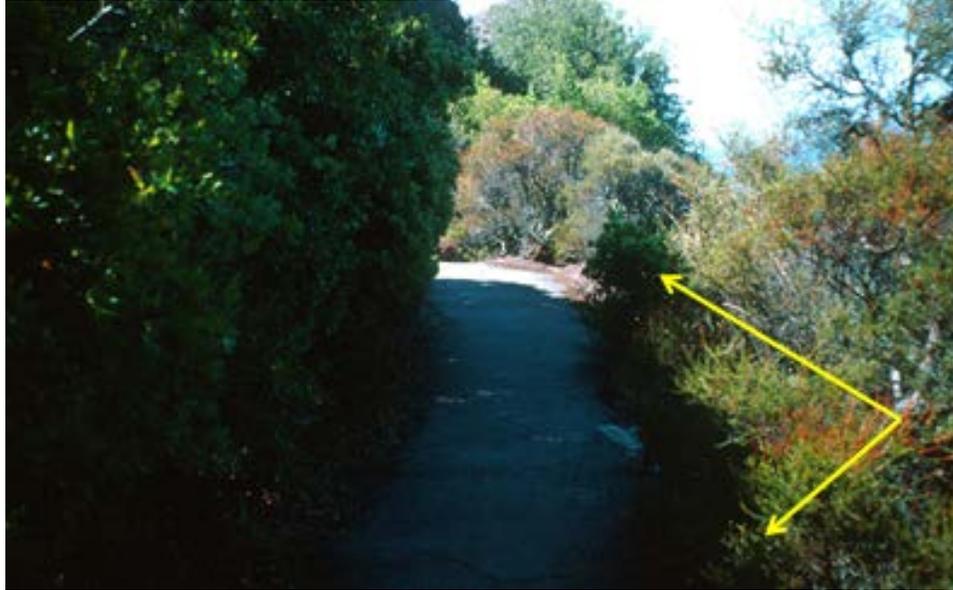
**Photo 8.21 - Native Vegetation (chemise and manzanita) for Edge Protection**

Edge protection consists of an elevated barrier to prevent users from going over the edge of the trail. Consider edge protection at locations where there is (1) a steep hazardous drop-off along the outer edge of the trail; (2) a steep linear grade, cross slope, or a precipitous drop-off; or (3) a combination of steep linear grade, cross slope, and change of direction. Site specific evaluations will determine potential safety risks and recommend proper design solutions. Consistent treatment of safety issues should occur along the trail. Edge protection may consist of native vegetation (if strong enough to restrain the user); logs or large tree limbs securely fastened to the ground; large rocks firmly attached to the ground or incorporated into a multi-tier retaining wall; or a combination of horizontal rails, diagonal rails, and bull rails on bridges and puncheons/boardwalks. All edge protection is installed to allow for overland sheet flow and to blend in with the natural surroundings. Edge protection is only installed where it is needed and its application is uniform and consistent across the trail system. (See Photos 8.21 and 8.22.)

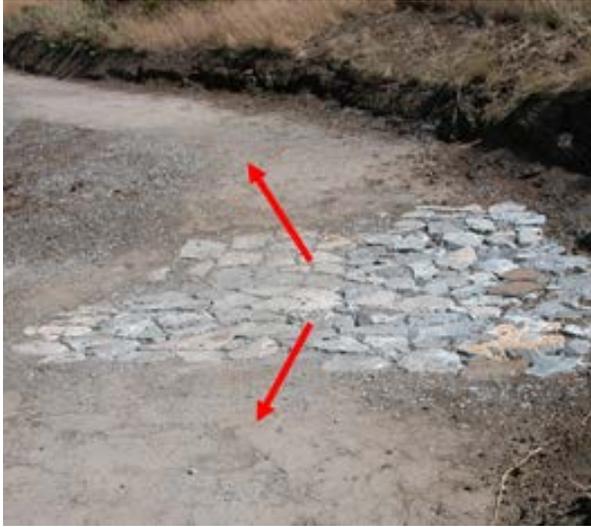
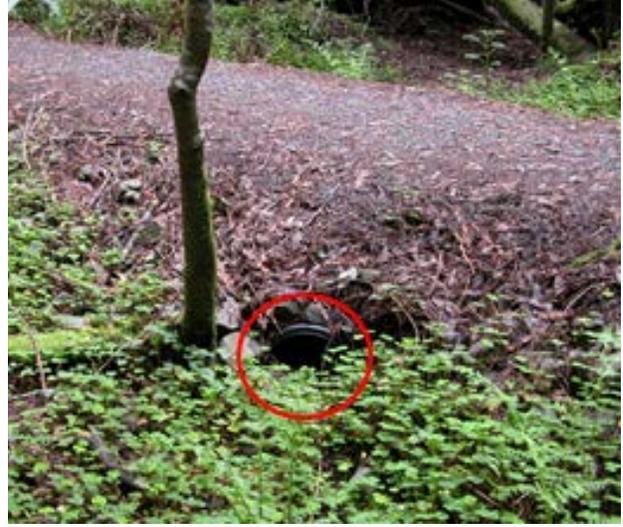
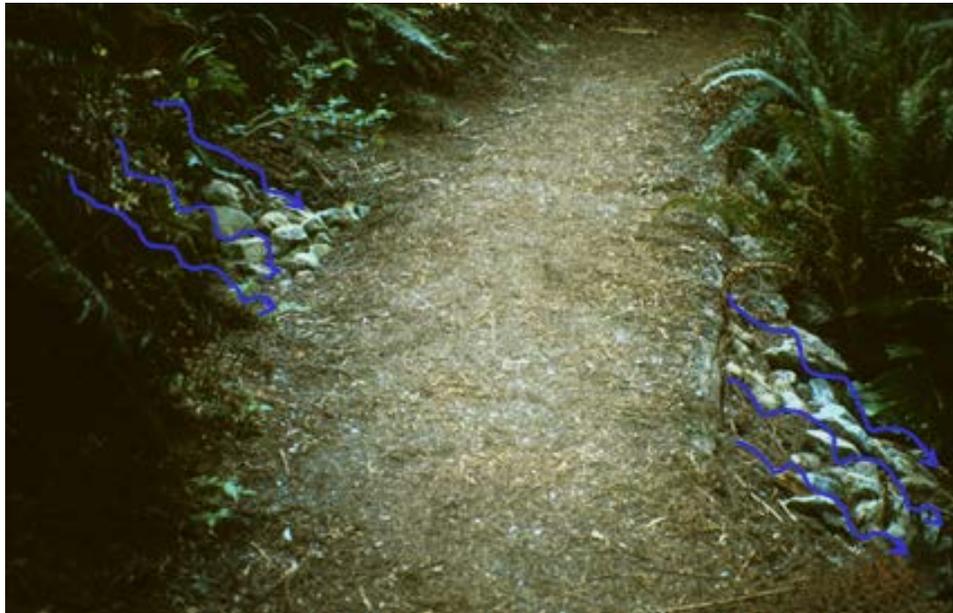
**Photo 8.23 - Armored Crossing (top left), Culvert (top right), and Drain Lens (bottom)**

Small watercourses can be traversed by installing armored crossings (cobblestones), drain lenses, or culverts (See Chapter 14, *Drainage Structures*). (See Photo 8.23.) Low volume perennial watercourses are crossed using puncheons or boardwalks. Bridges are constructed to cross large perennial streams. These structures must be designed to have a final elevation at trail grade and meet linear grade, cross slope, tread obstacle, and clear space opening requirements. Puncheons and bridges should have edge protection. When the trail grade approaching a watercourse crossing is too steep to comply with accessibility standards, puncheons, boardwalks, and bridges can be elevated and lengthened to reduce the approaching trail grade and bring it into compliance. (See Photo 8.24.)

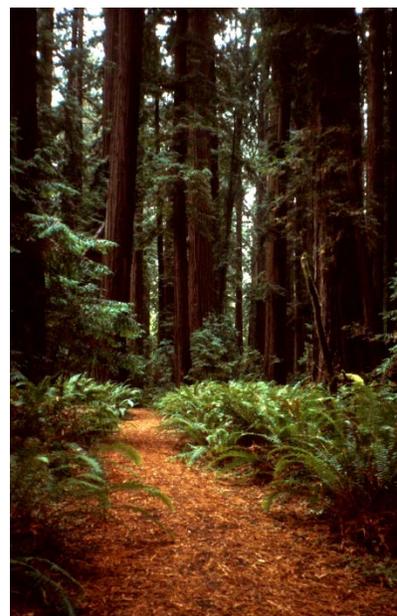
**Photo 8.25 - Use of Sinuosity and Soft Irregular Edges**

During construction, every attempt is made to match the building materials to the natural environment and local architecture. Native materials such as rocks, logs, and soil are used to the extent practical. If synthetic materials are used (cellular confinement and geotextile fabric), they are covered by native soil and vegetation. Applying the principles of curvilinear alignment, the trail should have an element of sinuosity, and its edges should be irregular and non-linear. Every attempt is made to create a finished trail that is seamless with the natural environment, providing a quality outdoor experience. (See Photo 8.25.)

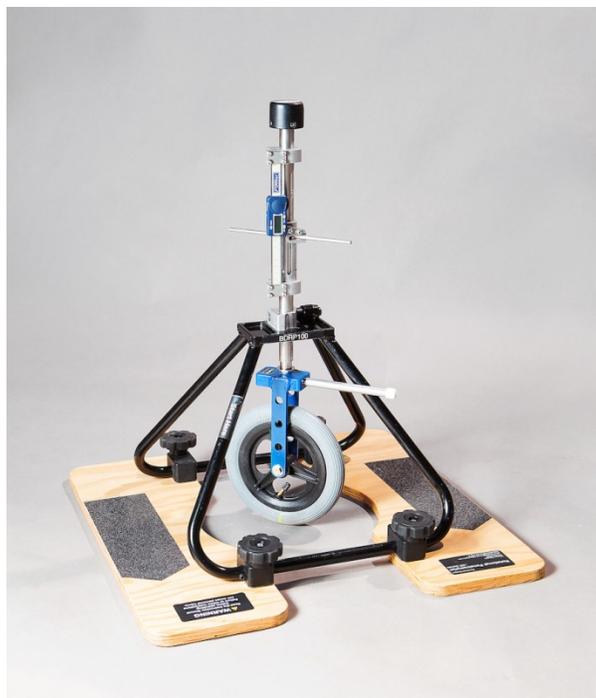
**Photo 8.26 - Rotational Penetrometer**

During construction it can be difficult to determine whether these conditions have been achieved. A more precise method for determining the firmness and stability of the trail tread is to test it with a rotational penetrometer. (See Photo 8.26.)

“Firmness” refers to the penetration of the surface when a foot or mobility assistive device applies downward force on the trail tread. “Stability” refers to the displacement of the surface when a foot or mobility assistive device rotates on the surface. Measurements conducted with a penetrometer must be performed during different seasons to ensure that tread conditions do not change as a result of soil moisture variations. The recommended penetration depths for firmness and stability are a maximum penetration of 0.3 inch or less for firmness and 0.5 inch or less for stability.
