Chapter 6. Results

STRUCTURES, FEATURES, AND STRATIGRAPHY

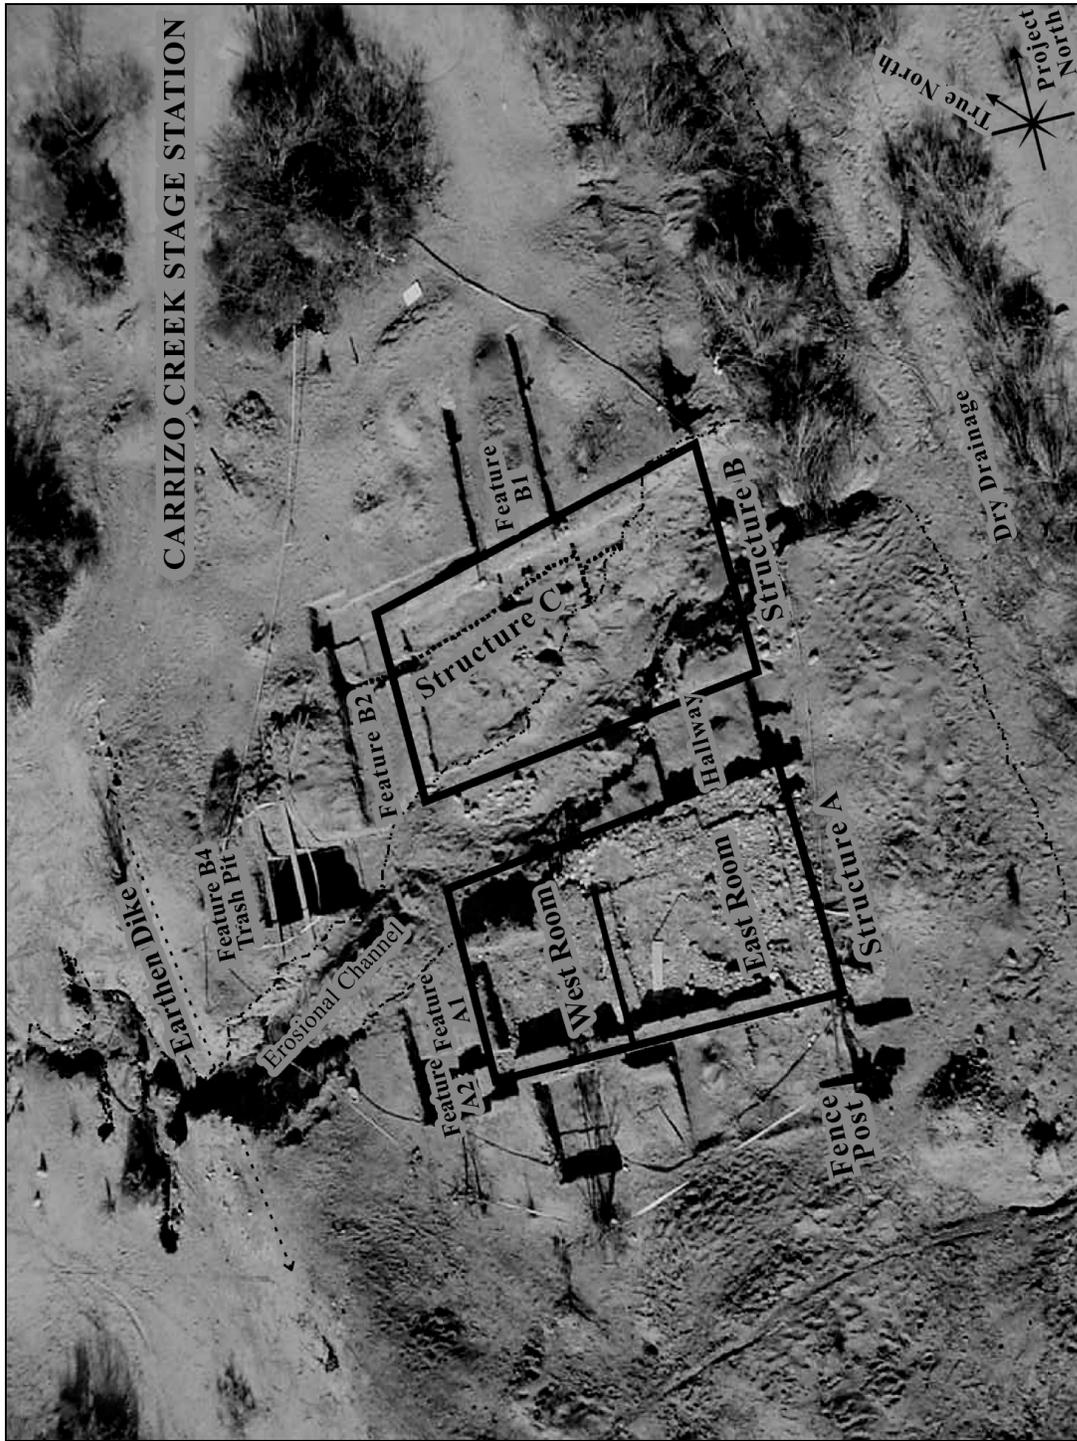
Figure 19. Schematic Drawing, 2003, Overlain on Aerial Photograph.

Excavations at Carrizo Stage Station revealed remains of three buildings and a number of related features (Figure 19). The southernmost was designated Structure A. Structure B remnants lie approximately seven feet north of and parallel to Structure A. Both of these adobe construction ruins measured approximately 30 feet east-west by 18 feet north-south. A narrow seven-foot-wide open hallway originally ran between them. The remains of Structure C underlie B and consist of the vestiges of a wattle and daub building and associated features. Features B1 and B2 represented the burned remains of additional small wooden outbuildings. Features A1, A2, and B4 were refuse deposits contemporary with the Overland Mail period (1857-1861). A large erosional channel, running through the center of the site, formed when Buster McCains’ earthen dike overflowed in the early 1980s and destroyed portions of all structure ruins and some of the features. This summary will describe the chronological sequence of the site’s major features and stratigraphic units listed in Table 4. More detailed discussions will be provided as each structure and feature is individually described.

Schematic Drawing of Carrizo Stage Station Structures and Features, April 2003, superimposed on aerial photograph (drawing by Bonnie Bruce, photograph by California State Parks).

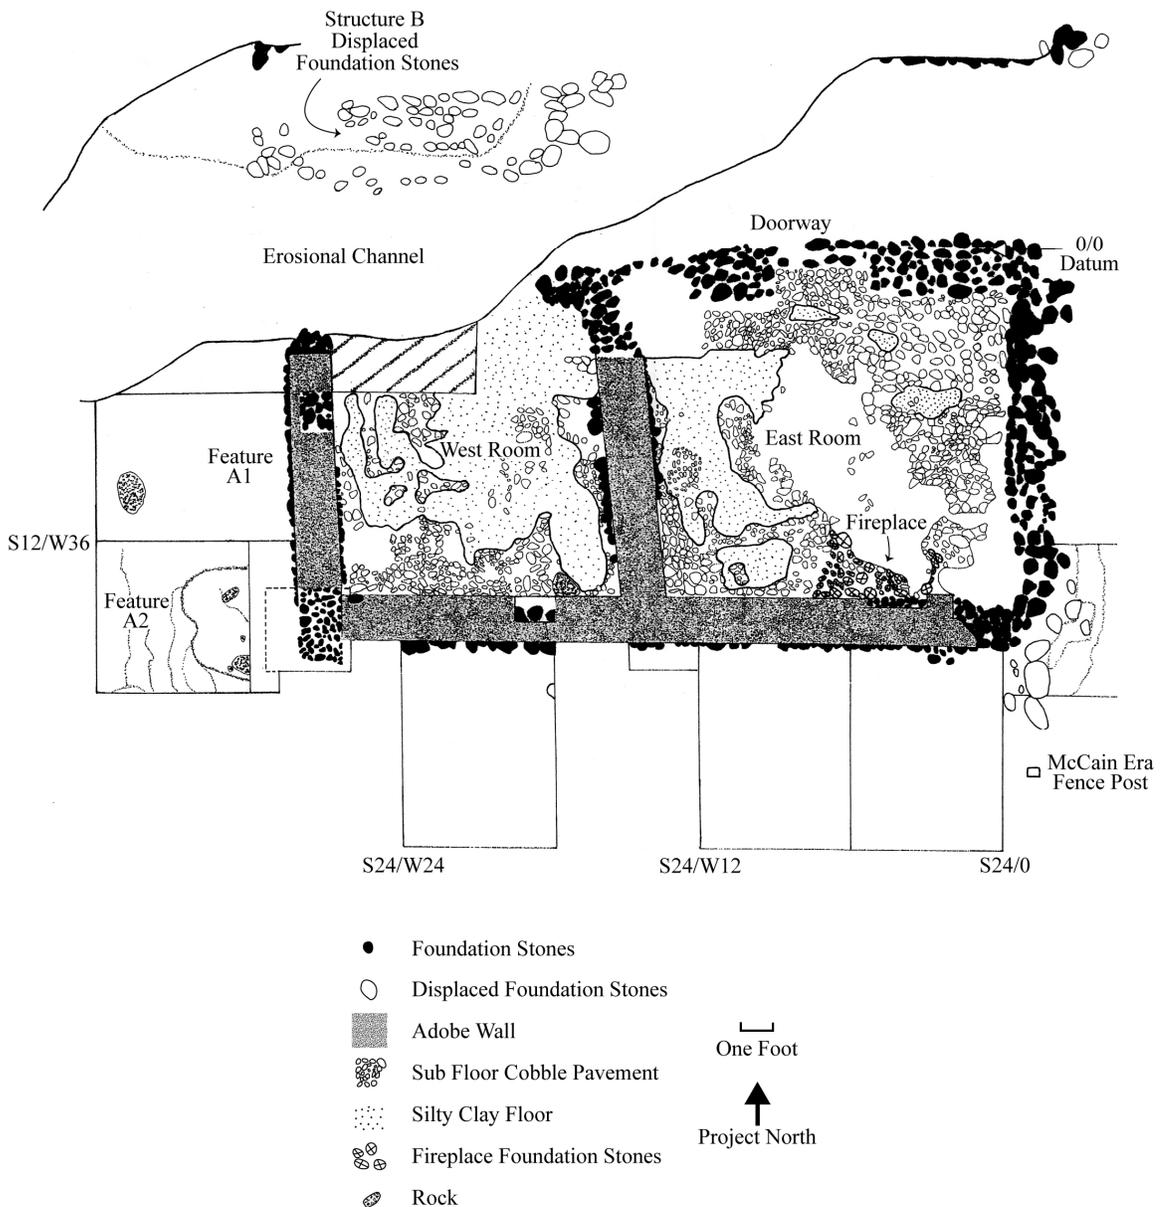
Figure 20. Structure A Archaeological Remains Site Map.

Structure A was a two room, rectangular adobe building that measured 30 feet east-west, by 18 feet north-south. A single adobe block interior dividing wall separated the dwelling into two rooms. This partition is not square with the rest of the building's floor plan, but angles slightly from the southeast to the northwest. Consequently the room measurements are not consistent from north to south. The west room measured approximately seven by six feet and the east room five by six feet (Figure 20).

used to construct the walls. The pebbles were covered with a packed layer of gray clayey silt about half an inch thick (see Figure 28b). On the north wall, near the northeast corner of the building, a doorway could be detected where pebble floor pavers covered the foundation in a three-foot-wide rectangle. A six-inch space between the edge of this section and the edge of the foundation suggests a wooden door frame was placed here (Figure 29a; see Figure 20).

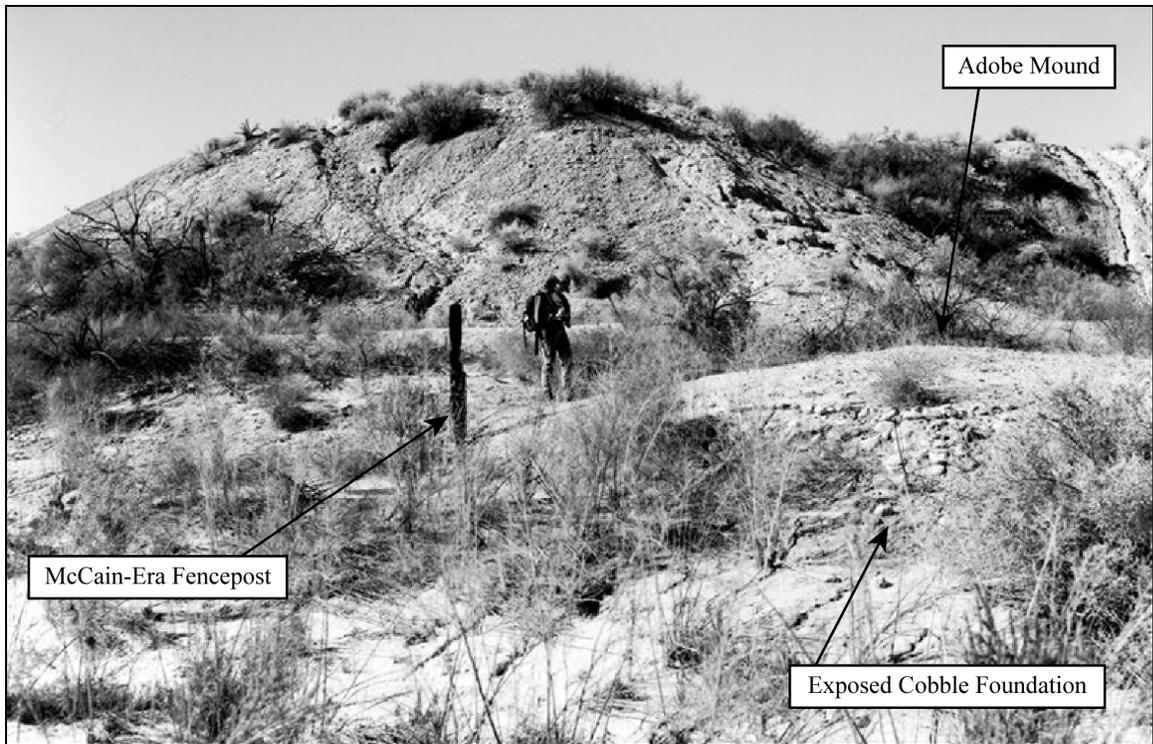
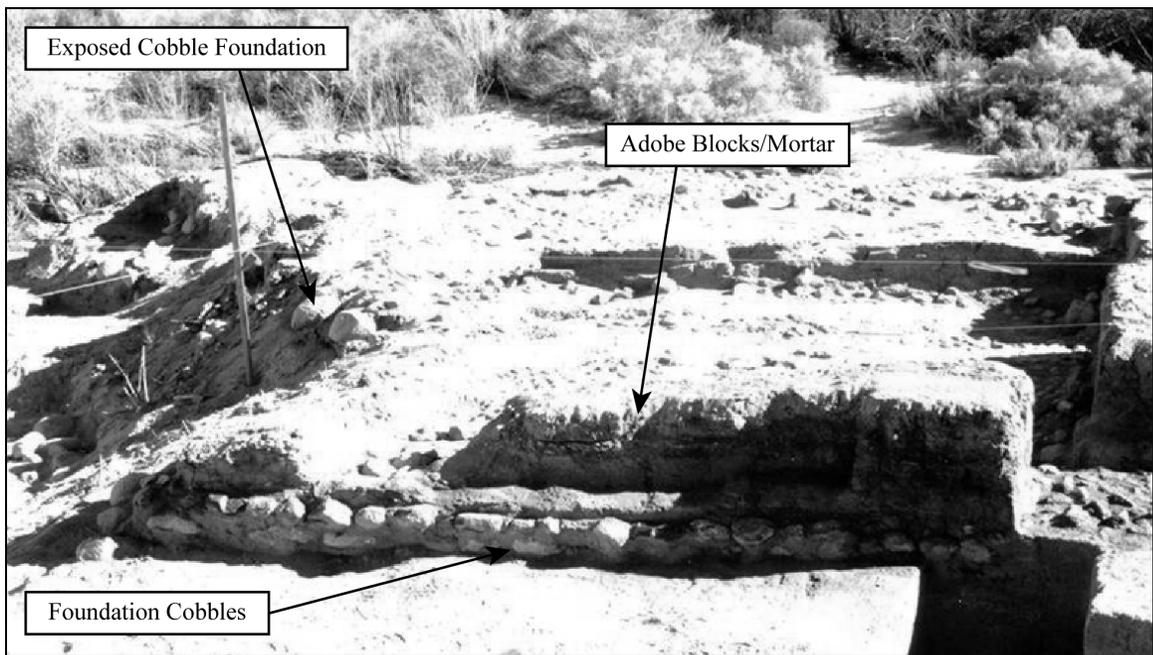
Figure 21. Carrizo Stage Station Site, 1999, and Structure A, 2002.

(a) Carrizo Stage Station Site, 1999, view to west (by Christopher Wray).

(b) Structure A, West Wall Detail, 2002, view to north-northeast (by California State Parks).

Condition and Stratigraphy: Prior to excavation, Structure A consisted of a small adobe mound approximately 24 to 30 inches high, covering an area of 25 by 35 feet. Along the eastern edge, erosion had exposed an alignment of foundation cobbles (Figure 21a). Excavation revealed remnant adobe wall segments, cobble foundation alignments, sections of articulated wall fall, and floors constructed of small cobble pavements covered with silty clay. The erosional gully cutting through the site had impacted the northwest corner of the Structure A ruin and completely destroyed about 1/8 of the building's remains.

Foundations: Exterior and interior foundations were constructed in an identical manner. They consisted of one to two courses of 6-to-8-inch diameter water-worn cobbles placed in alignments approximately 24 to 30 inches in width (see Figure 21b). On the east end of the building the cobbles were laid directly on the ground surface and mortared together with dark brown clay. Due to a slight rise in the terrain, foundations on the west wall and west end of south wall of the building were placed in a shallow trench (Figure 25 and Figure 26). The interior wall sits on a foundation identical in construction to the exterior walls.

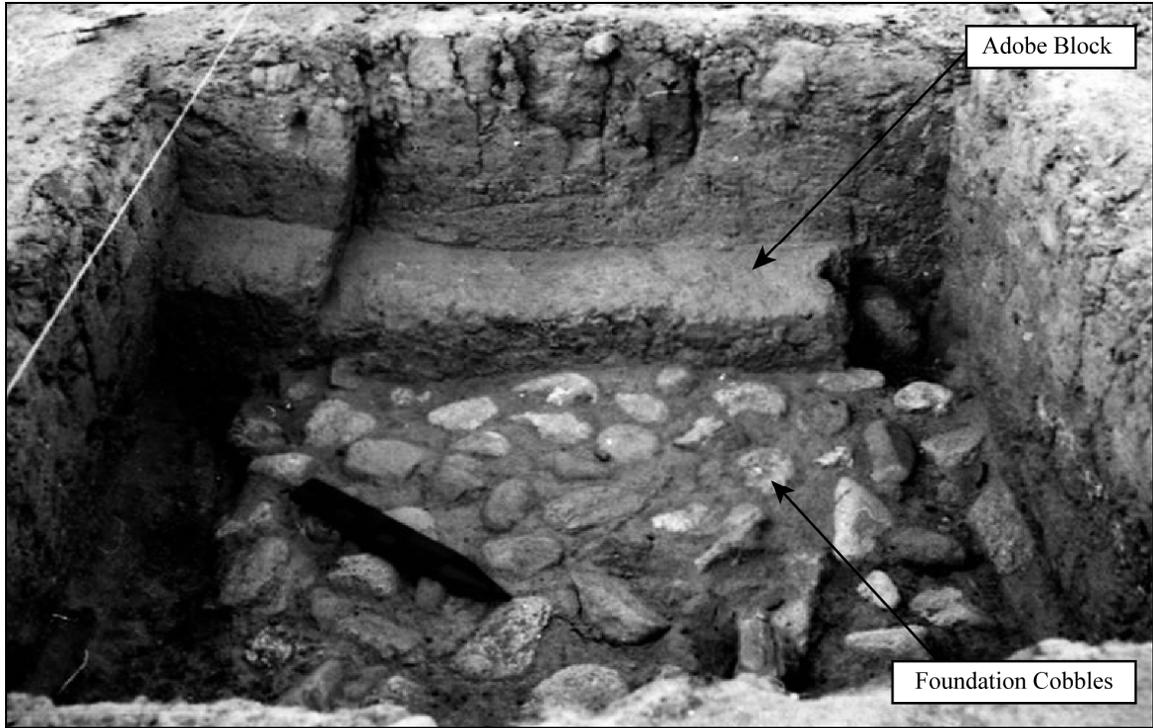
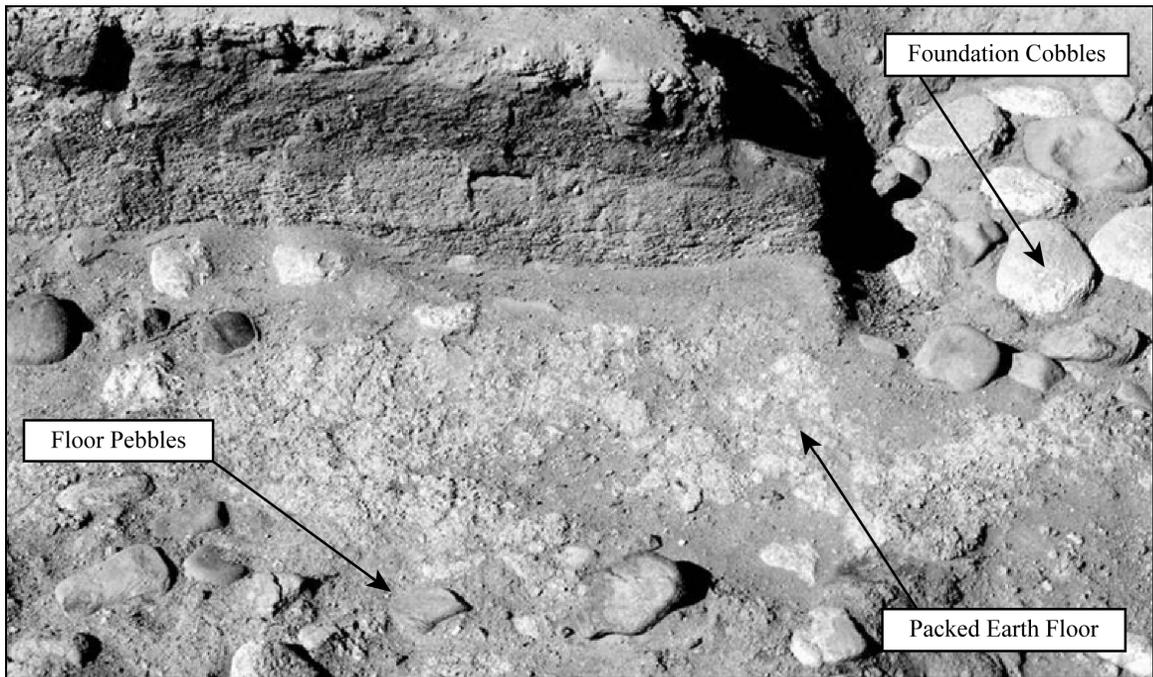
Figure 28. Structure A Foundation Cobbles and Compacted Floor.

(a) Structure A, Southwest Corner, 2001, view to northeast (by California State Parks).

(b) Structure A, Unit 6S/24W, 2002, view to northwest (by California State Parks).

however block sizes varied slightly, and some were as long as 26 inches. To receive the blocks, the top of the cobblestone foundations was covered with a layer of dense clay approximately two inches thick. The bottom row of block was laid on this clay as a single header course across the foundations. The walls were then raised in alternating courses of two parallel 12-inch-wide stretcher bonds, and single rows of 24-inch-wide header bonds, with approximately one-inch-thick, dark reddish-brown clay mortar joints. In spite of the use of a dense clay mortar, joints between the blocks were difficult to define, especially in the upper courses where extreme weathering had occurred (Figure 27 and Figure 28a).

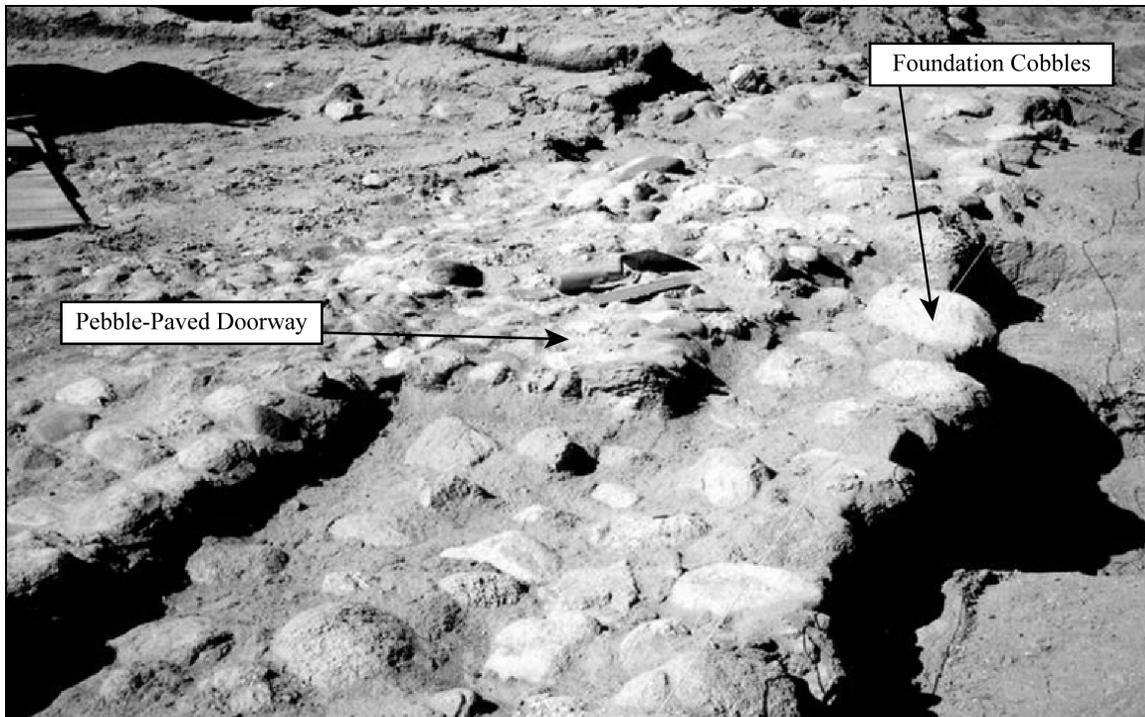
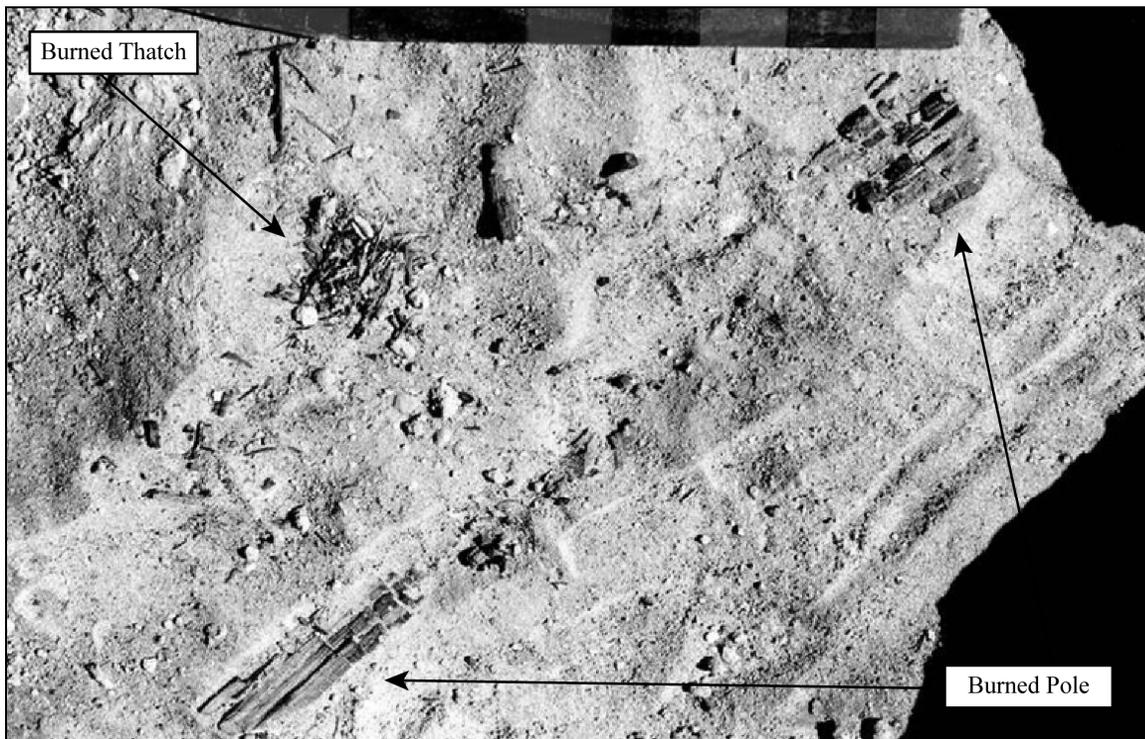
Figure 29. Structure A North Wall Foundation, Doorway, Burned Thatch, and Pole Fragments.

(a) Structure A, North Wall Foundation and Doorway, 2002 (by California State Parks).

(b) Structure A, Unit S6/W6, Burned Thatch and Pole Fragments, 2002, view to west (by California State Parks).

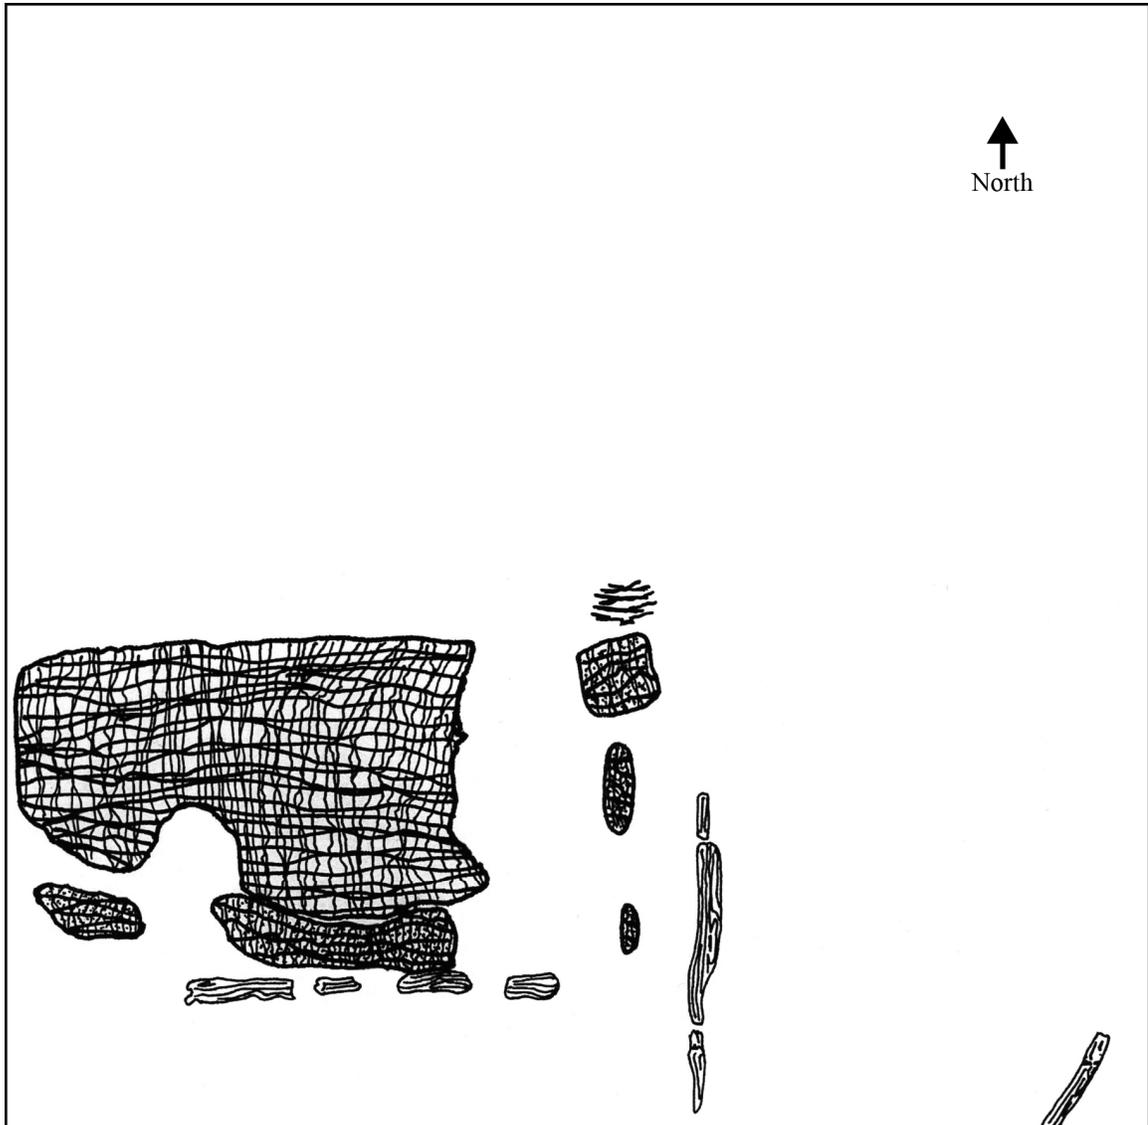
Figure 30. Structure A Plan View of Roof Fall in West Room, Unit S6/W6.

Burned Thatch
-

Burned Limb Segments
-

Unburned Twigs
-

Unburned Thatch

Roof fall was encountered in the southwest corner of the east room. This consisted of burned and unburned sections of roof thatching, made up of small interwoven twigs varying from 1/8 to 1/4 inches in diameter. Associated with these were segments of burned limbs one to two inches in diameter that probably served as support pieces (Figure 29b). No evidence of mud or any other material covering the thatch was found. This complies with the stage station description by Russling in 1867, who saw the roof constructed of some poles thrown across the top of the building and covered with willows and coarse grass (Figure 30).

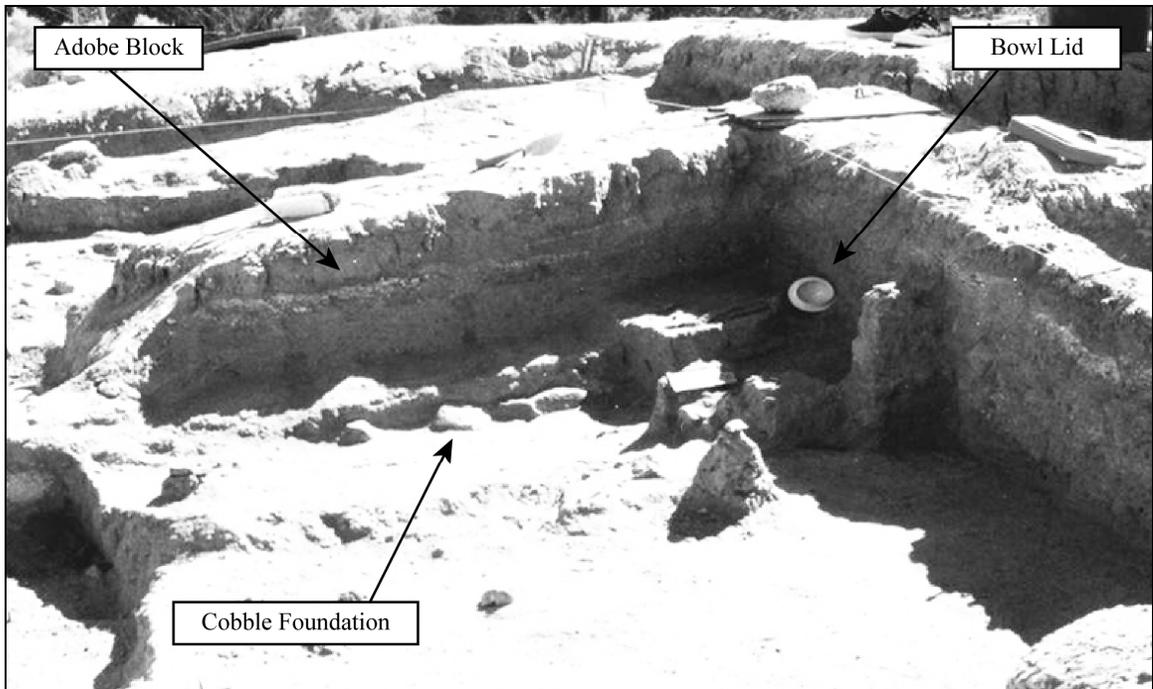
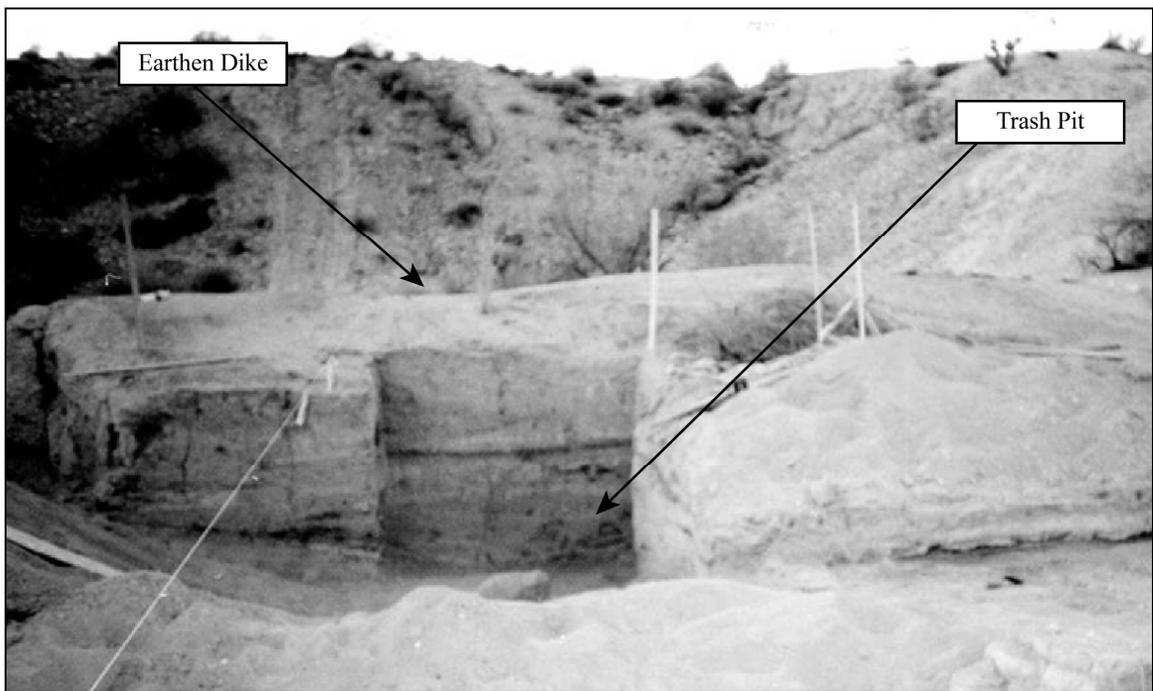
Figure 34. Features A1/A2 and B4.

(a) Structure A, 6S/30W, Feature A1/A2, 2002, view to southeast (by California State Parks).

(b) Structure A, Feature B4, West Wall Profile, 2002, view to west (by California State Parks).

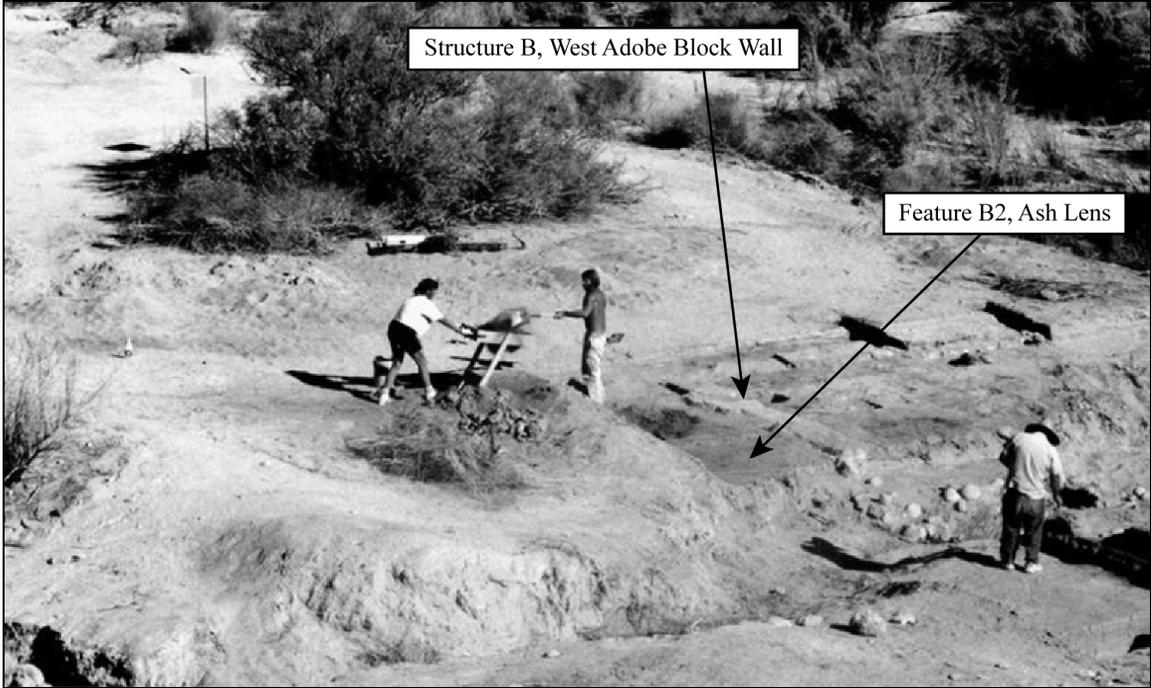
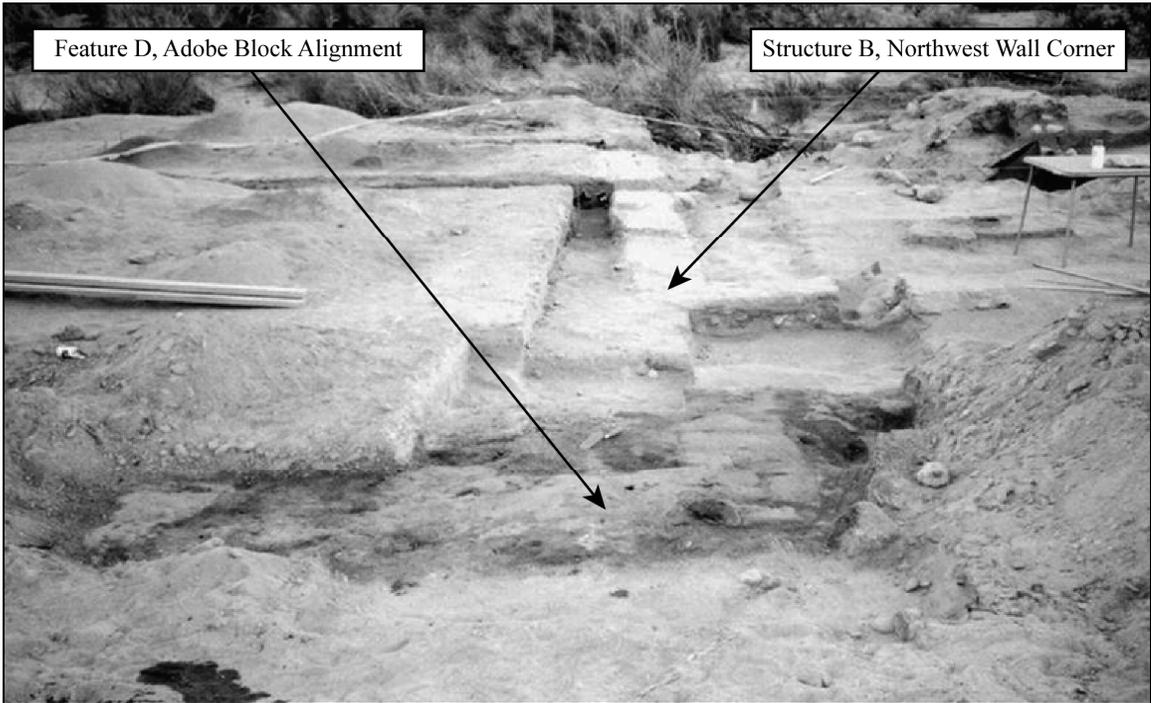
Figure 37. Feature B2 and D.

(a) Structure B, Feature B2, 2002, view to northeast (by California State Parks).

(b) Structure B, Feature D, 2002, view to southeast (by California State Parks).

Feature B2 was a rectangular shaped ash lens approximately one inch thick that measured seven by 14 feet. It consisted of a thick dark wood ash that had an exceptionally high number of square nails. Almost 12 square feet of the feature was excavated and screened resulting in 95 nails (Figure 37a). Other artifacts included a large quantity of carbonized barley seed, a pepper sauce bottle, a lead round ball bullet, a percussion cap, a clay smoking pipe, and fragments of a Native American pottery vessel.

Two rectangular alignments of adobe blocks were encountered on the west side of Feature B2. These appeared as a thin lens of gray clay one to two inches thick and about 24 inches wide (see Figure 37b). The true nature of these remains have not been determined. They may represent the adobe corral that adjoined the station buildings that was observed by the Conklings in the 1920s.

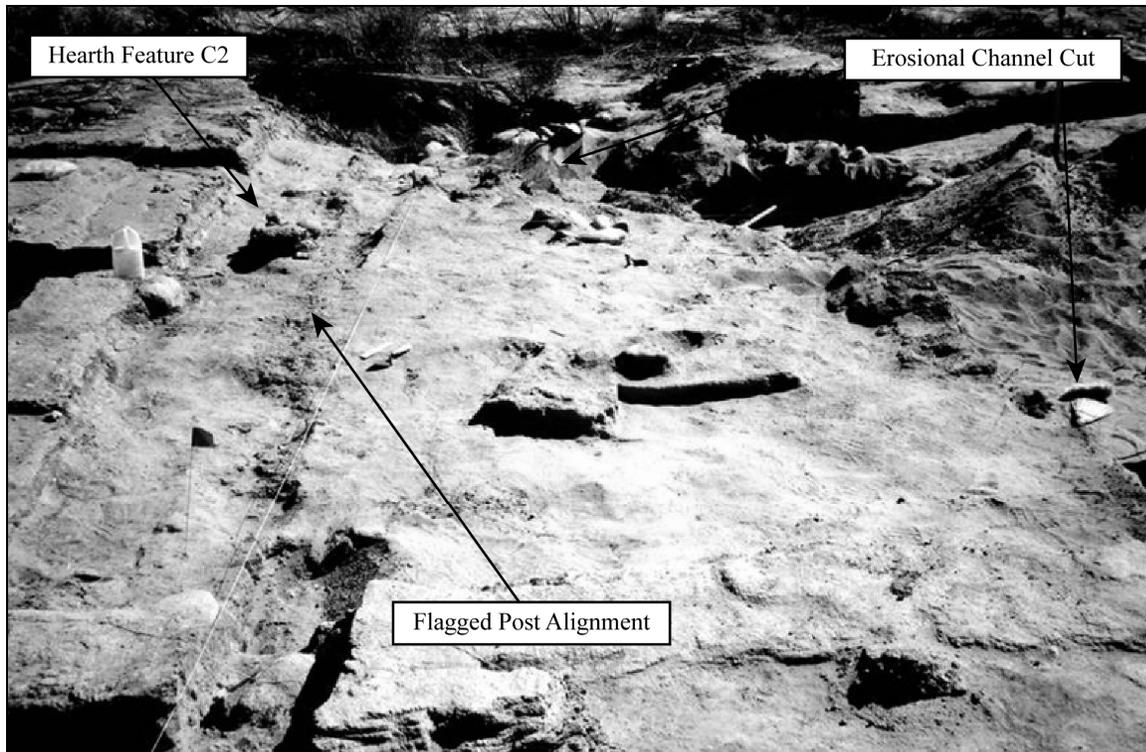
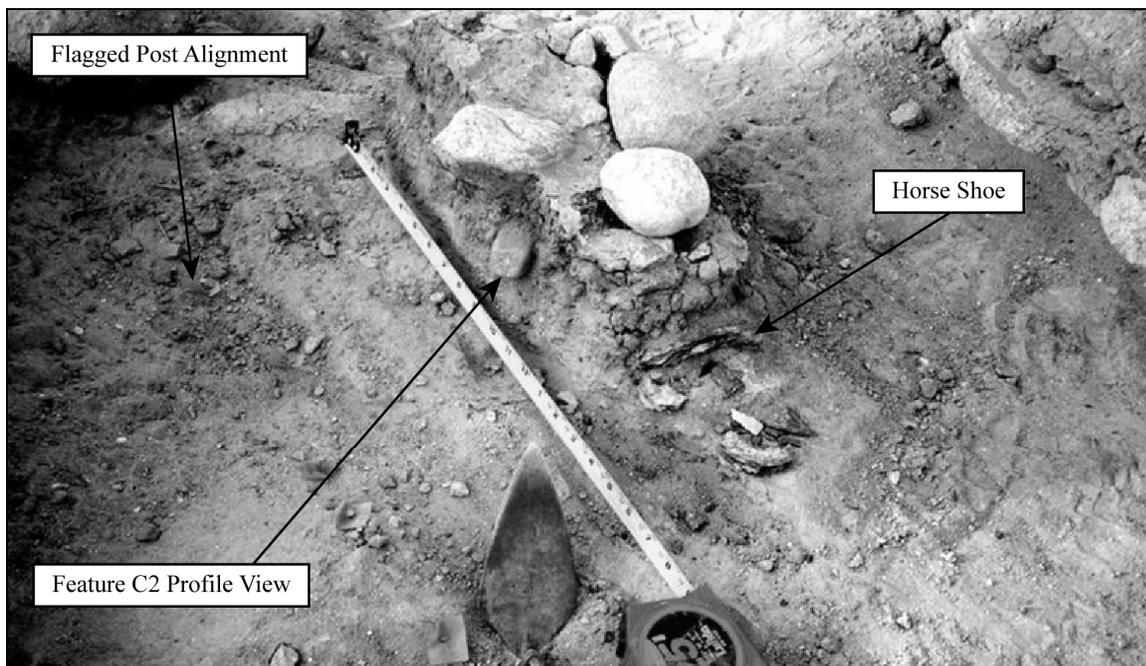
Figure 42. Structure C Posthole Alignment and Feature C2.

(a) Structure C, Posthole Alignment, 2002, view to southeast (by California State Parks).

(b) Structure C, Feature C2, 2002, view to north (by California State Parks).

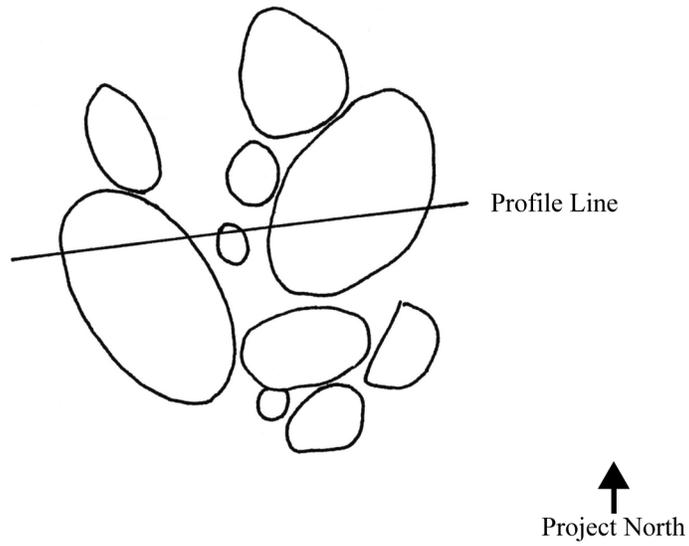
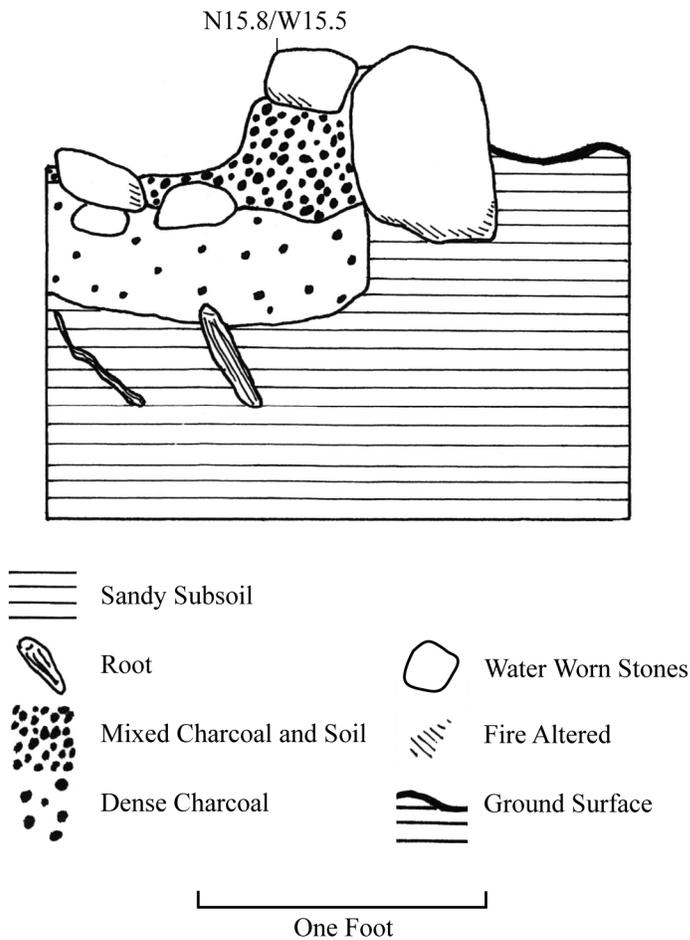
Figure 44. Feature C1 Hearth at Unit N15.8/W15.5.

PLAN VIEW

PROFILE VIEW

There was no definite floor defined for Structure C. The post molds and stakes were excavated into a coarse sandy subsoil that underlies this entire portion of the site. Two small cooking hearths, designated Features C1 and C2, occurred in association with the wattle and daub remains. These contained the only artifacts recovered that could be associated with the structure. Both hearths measured approximately 12 inches in diameter and eight inches deep. They were located in the western portion of the structure, one against the north side of the main stake wall alignment (Figure 42b). The hearths consisted of loosely-packed water-worn stones with concentrations of ash and charcoal. Pieces of ground stone implements, including a combination mano and pestle and another mano fragment, were identified in C1 (Figure 44). Feature C2 contained two manos (Figure 45). Metal fragments in Feature C1,

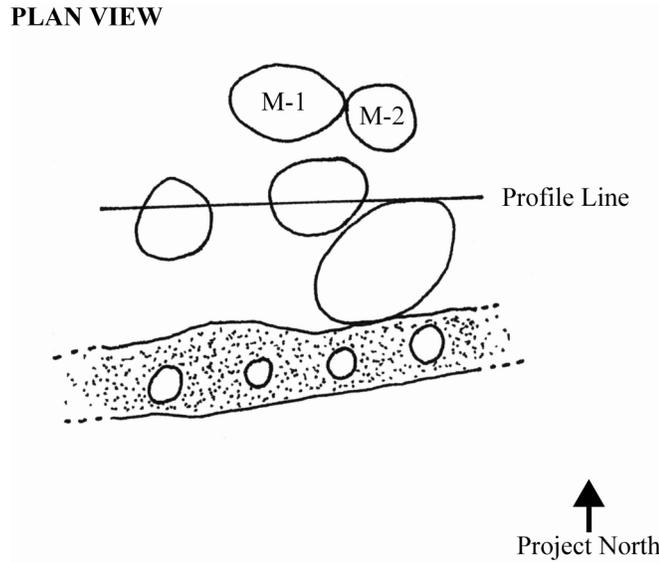
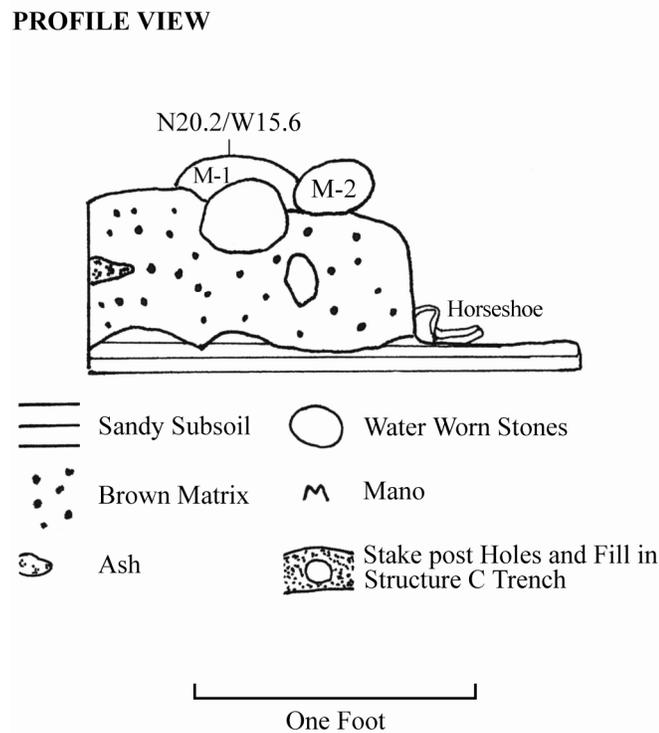
Figure 45. Feature C2 Hearth at Unit N20.2/W15.6.

PLAN VIEW

PROFILE VIEW

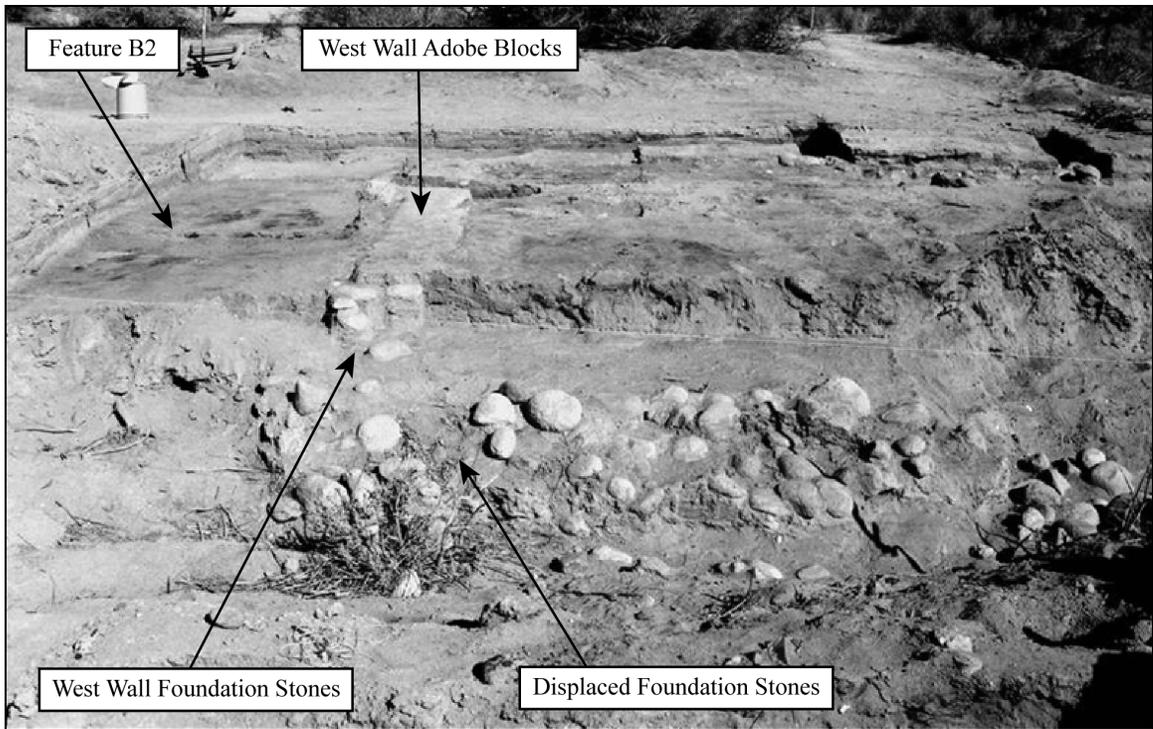
(a) Structure B, West and South Wall Foundation Stones, 2002, view to north (by California State Parks).

Foundations: The foundations of Structure B are similar to those of Structure A. They are 18 to 24 inches wide and consist of one to two courses of 6-to-8-inch diameter round and oblong water-worn cobbles. Some are up to 12 inches in length. The stones are not as tightly packed as in the foundations of Structure A. However, as in Structure A, they are placed at ground surface and mortared together on the east end of the building and set in shallow trenches at the west end in order to compensate for a slight rise in the terrain.

Blocks and Walls: Wall remnants of Structure B consisted of a layer of dense gray clay, two to four inches thick, and approximately 24 inches wide, on top of the foundation cobbles. The footprint of the building could easily be seen by the dark gray outline in the surrounding ashy brown soil. This is all that remained of the bottom course of adobe blocks. The block material was very different from that used in Structure A, where the adobes had been made from a tan silty loam. The blocks in Structure B were of a dense gray clayey silt very similar to the material used in Structure A to cover the pebble floor pavement. Mortar must have been of the same material since no mortar joints could be detected. The fact that the wall material is consistently about 24 inches wide suggests that, as in Structure A, these block measurements probably averaged 12 x 24 x 4 inches and were laid in alternating courses of a single row of headers and two parallel rows of stretchers.

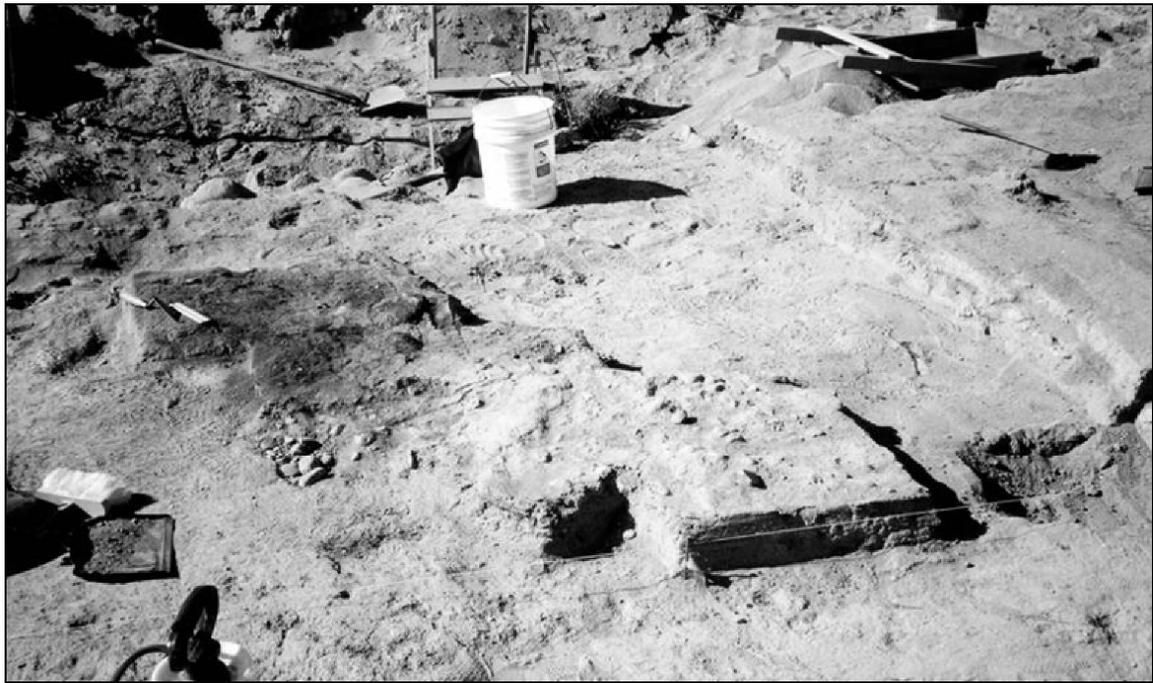
Figure 48. Structure B Wall Foundation Stones and Fire Hearth Feature.

(b) Structure B, Fire Hearth Feature B5, 2002, view to southwest (by California State Parks).

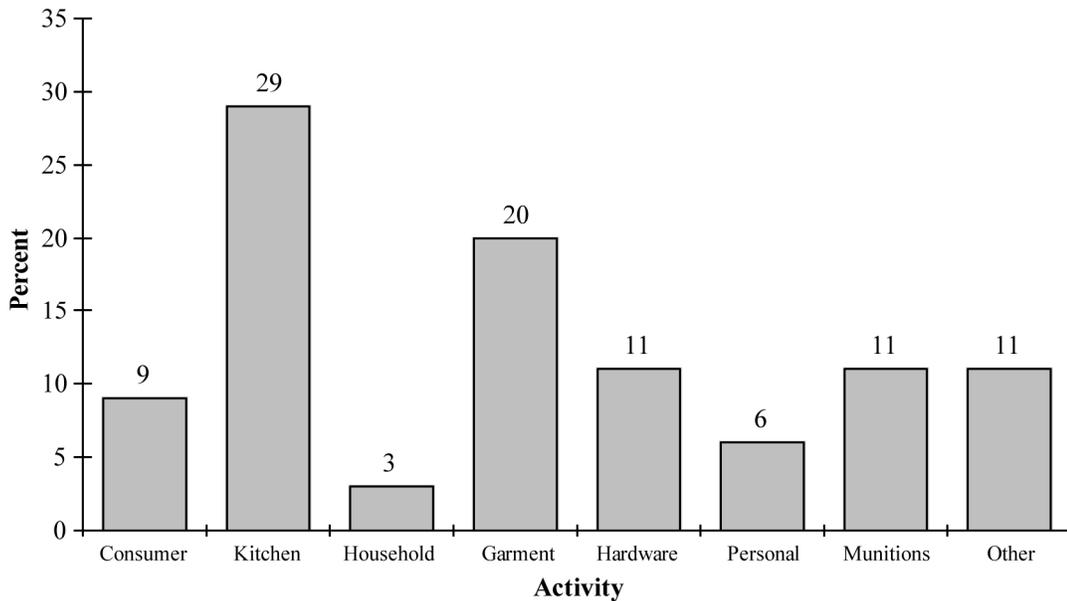
Figure 49. Structure B Activity Profile without Building Materials.

The artifact activity profile for Structure B is shown in Table 12. It is shown without building materials in Table 13 and in Figure 49. The assemblage is dominated by kitchen items at 29 percent. This is followed by garment items at 20 percent, hardware and munitions at 11 percent, and consumer items at nine percent. Other activity groups made up less than five percent each of the artifact collection. Garment items included only overall and jeans fly buttons. Munitions consisted of percussion caps and a Civil War era mini ball. Kitchen items included fragments of eight Native American cooking pots, pieces of flow blue and Rockingham decorated ceramics, and a single peach pit. Fragments of liquor and culinary bottles made up the consumer items. The activity profile, the sooty scorched floor, and the small hearth of Feature B5 all reveal that this building was used as a kitchen, although the garment items, personal items, and munitions show that other activities also occurred there.
