5.3.12 Scenic Resources

Kings Beach State Recreation Area General Plan

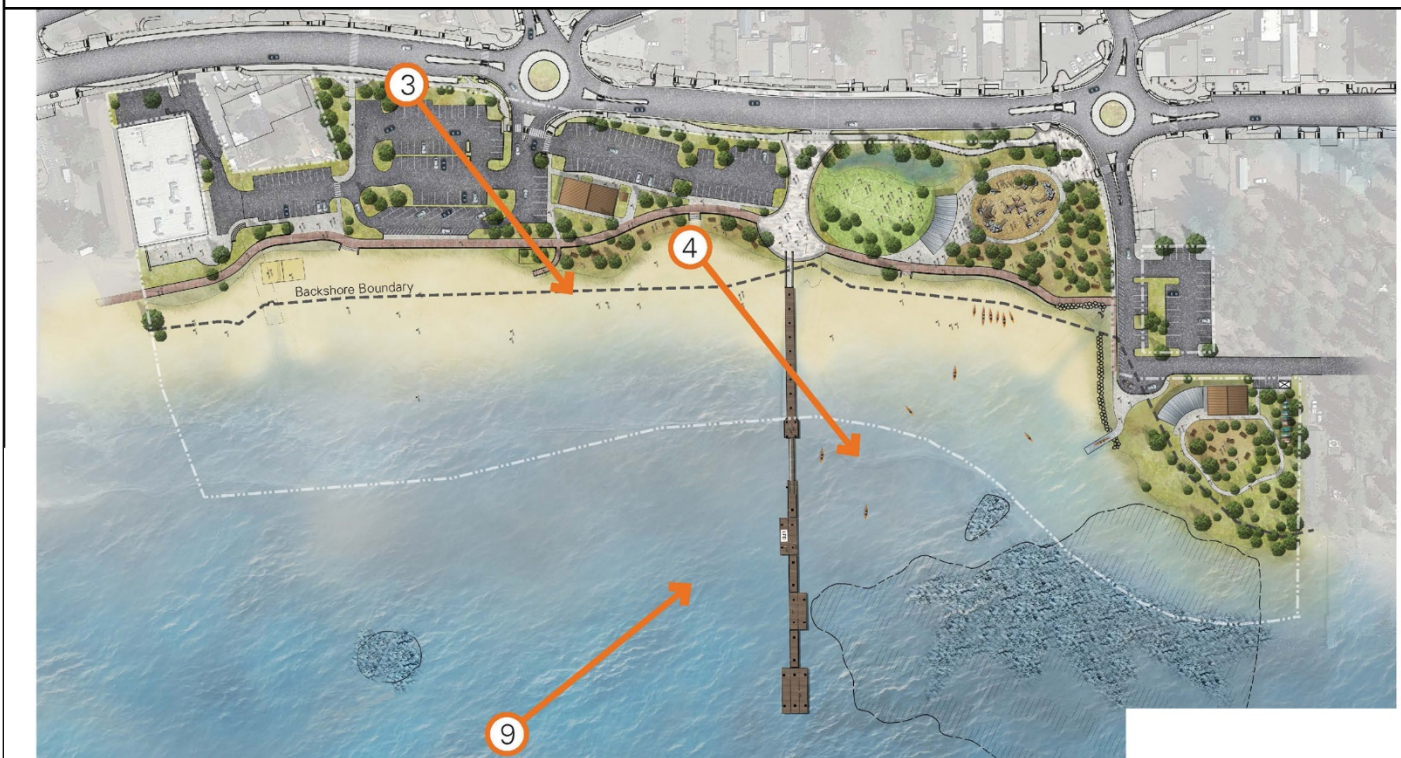
Alternative 3 Viewpoints

The viewpoints shown in Exhibit 5.3.12-2 reflect the views most likely to be degraded by changes in visual conditions under Alternative 3. Exhibit 5.3.12-6 shows the existing and futures views toward Lake Tahoe from Viewpoint 3, which is located at the TRPA-designated roadway Scenic Resource 20-5 along SR 28 just west of the Bear Street roundabout facing southeast. In addition to being a TRPA-designated scenic resource, this viewpoint reflects the view from SR 28 that has the highest probability of being degraded by Alternative 3 because it provides open views to Lake Tahoe, which could be affected by new structures.

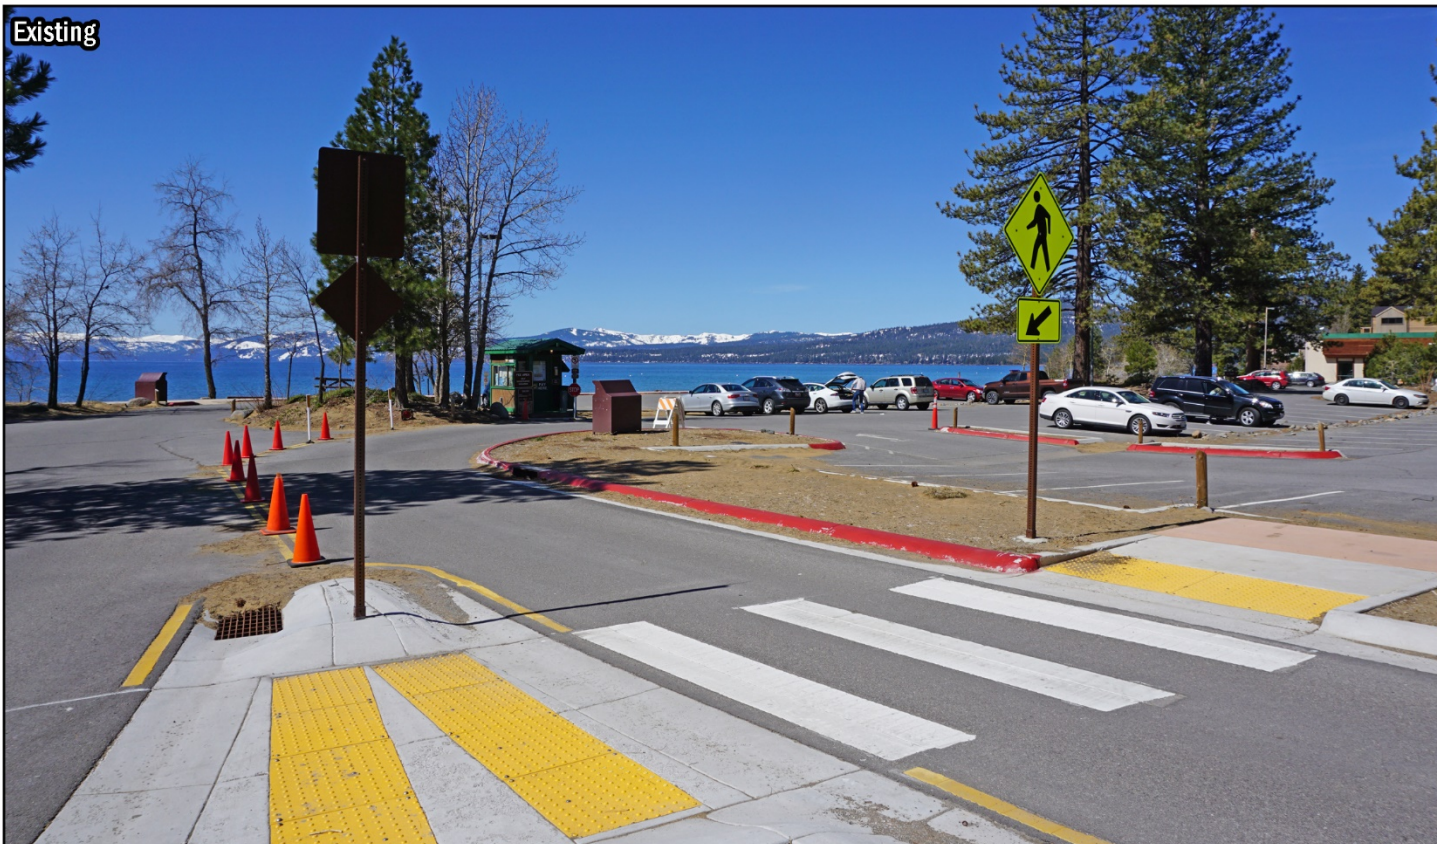
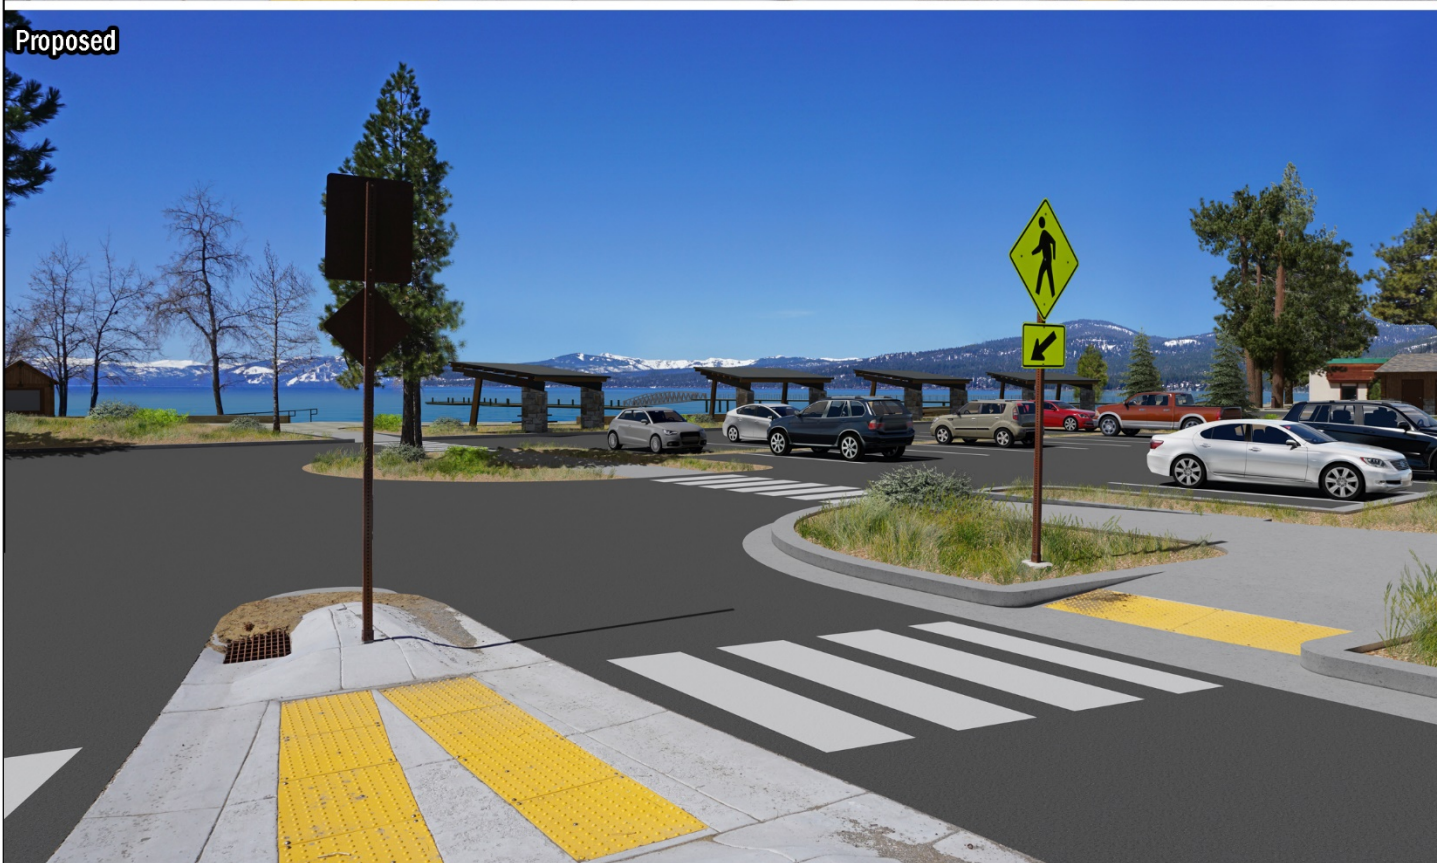
Existing

Proposed

Exhibit 5.3.12-8 shows the existing and future views from Viewpoint 5, located on the south side of SR 28 just east of the Bear Street roundabout, facing southwest. This viewpoint reflects the view from SR 28 that has the highest probability of being degraded by Alternative 4 because it provides relatively open views to Lake Tahoe, which would be affected by new structures. As described above, TRPA designated roadway Scenic Resource 20-5 along SR 28 just west of the Bear Street roundabout facing southeast across the KBSRA parking lot towards Lake Tahoe. However, the simulation was prepared for Viewpoint 5 instead because it provides views of the new structures that would be visible from Scenic Resource 20-5, as well as views of the new pier, which would not be visible from Scenic Resource 20-5. Therefore, this viewpoint includes the views most likely to be degraded by Alternative 4.

In the simulation of Alternative 4, the vehicular entrance continues to dominate the immediate foreground. The western pier is also visible on the lake, and the impact of this pier is evaluated separately, below. In the simulation, the existing entry kiosk/visitor contact station has been relocated to the far-left side of the view. The condition of the structure is improved, but it continues to block a portion of the lake view behind it. A reconfigured parking lot continues to dominate the right side of the view. The redeveloped parking lot with enhanced landscaping provides a moderate increase in the visual quality of the parking lot. The North Tahoe Event Center is still visible on the right side of the view and some tree removal is visible on the right side and near the center of the view. The most obvious visual change is the addition of four new shade structures between the parking lot and the beach. While the lake is partially visible through the shade structures, the roofs and posts of the structures obscure views of the lake and distant mountains. These shade structures decrease the unity of the view and block important visual elements, including open water, distant shoreline, and distant ridgelines. As shown in Exhibit 5.3.12-8, the views blocked by the shade structures are not offset by the removal of existing features that block views of Lake Tahoe. Thus, the shade structures would result in a net decrease in views of Lake Tahoe from this viewpoint. When considered in the context of the entire roadway travel unit, these changes would degrade views of the lake from the roadway, but not to the extent that would reduce the scenic threshold score for the roadway travel unit. However, these structures would degrade an existing view of Lake Tahoe and would reduce the TRPA scenic threshold score for Scenic Resource 20-5. Thus, the impact would be **significant**.

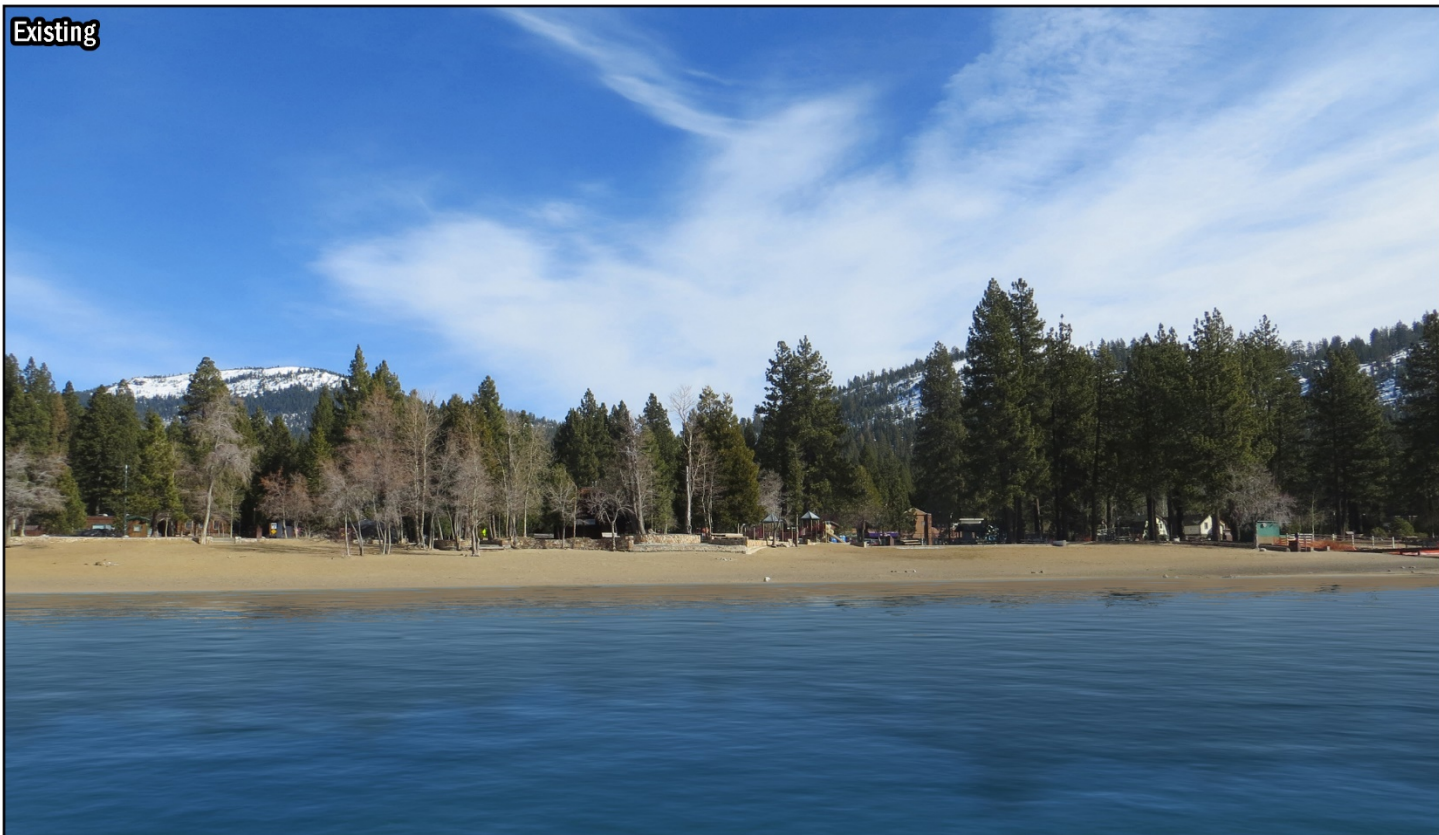
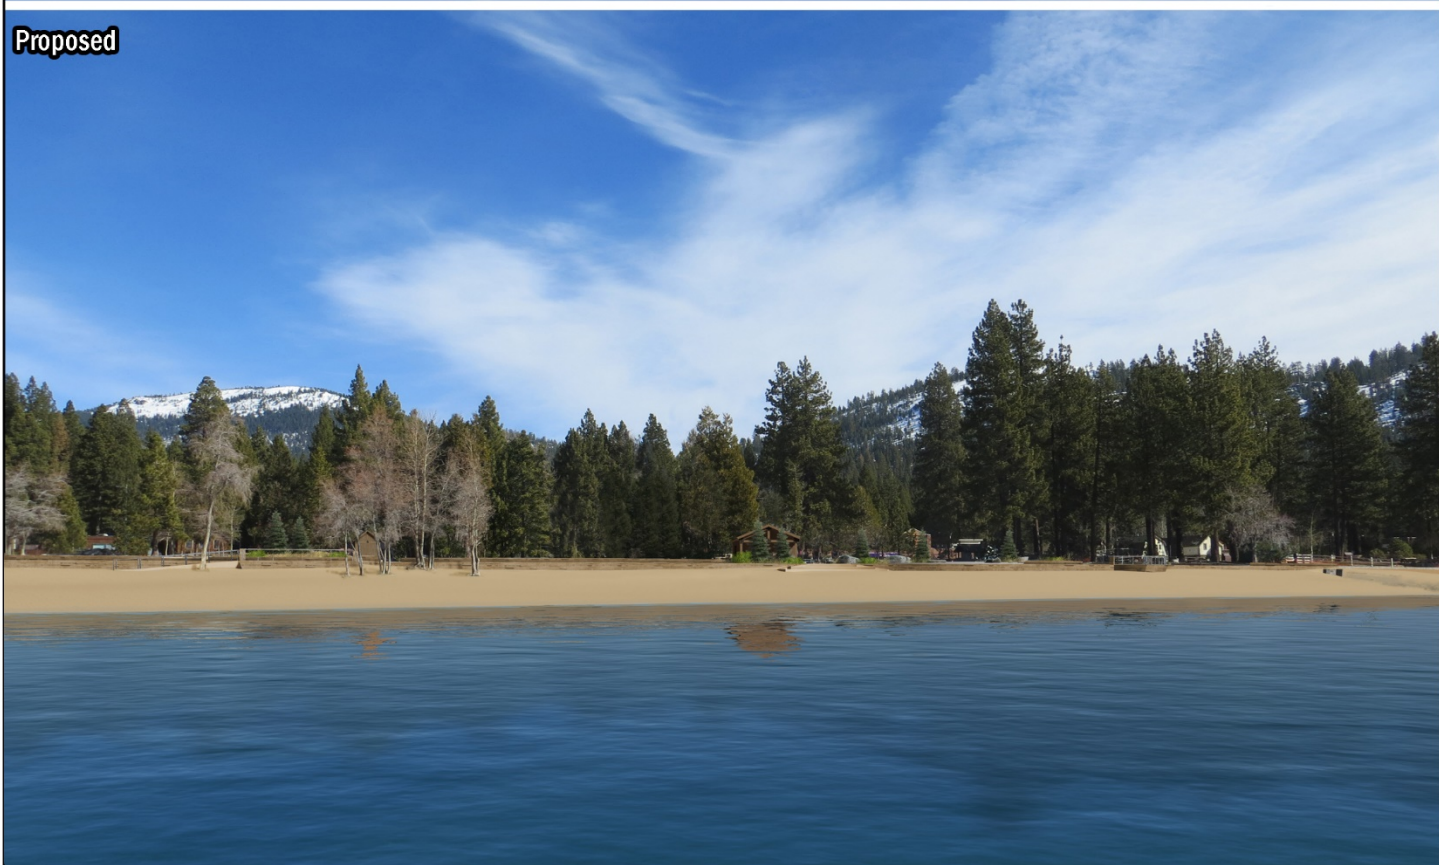
Existing

Proposed

Exhibit 5.3.12-10 shows the existing and future views from Viewpoint 7, on Lake Tahoe, approximately 300 feet from the high-water mark and facing north-northeast. This viewpoint reflects the view from Lake Tahoe that has the greatest chance of being degraded by Alternative 2 because it provides direct views of the structures that would be most visible, including the new restroom, promenade/sand wall, and visitor contact station. In the existing view, the shoreline is dominated by a mix of deciduous and conifer trees. The existing rock retaining walls are visible as tan walls near the center of the view, and the restroom is visible as a dark structure, partially obscured by trees directly behind the retaining wall. The playground is clearly visible just to the right of the retaining wall, and the green concessionaire building and the landside end of the pier are visible on the right side of the view. Several buildings north of KBSRA are also visible through the trees. These off-site buildings include the brown building in the left side of the view, and the brown and yellowish buildings between the playground and the concessionaire building. Overall, the quality of the existing view is good because of the predominance of trees along the shoreline, which screen most visible signs of development.

As described above, Alternative 2 would alter man-made features visible from Lake Tahoe, which is one of the three criteria used to determine shoreline travel unit threshold scores. Based on the simulation in Exhibit 5.3.12-10 and the visual magnitude calculations in Appendix B, these visual changes would not reduce the quality of views from Lake Tahoe or degrade the TRPA scenic quality ratings for the applicable shoreline travel units. Thus, the impact would be **less than significant**.

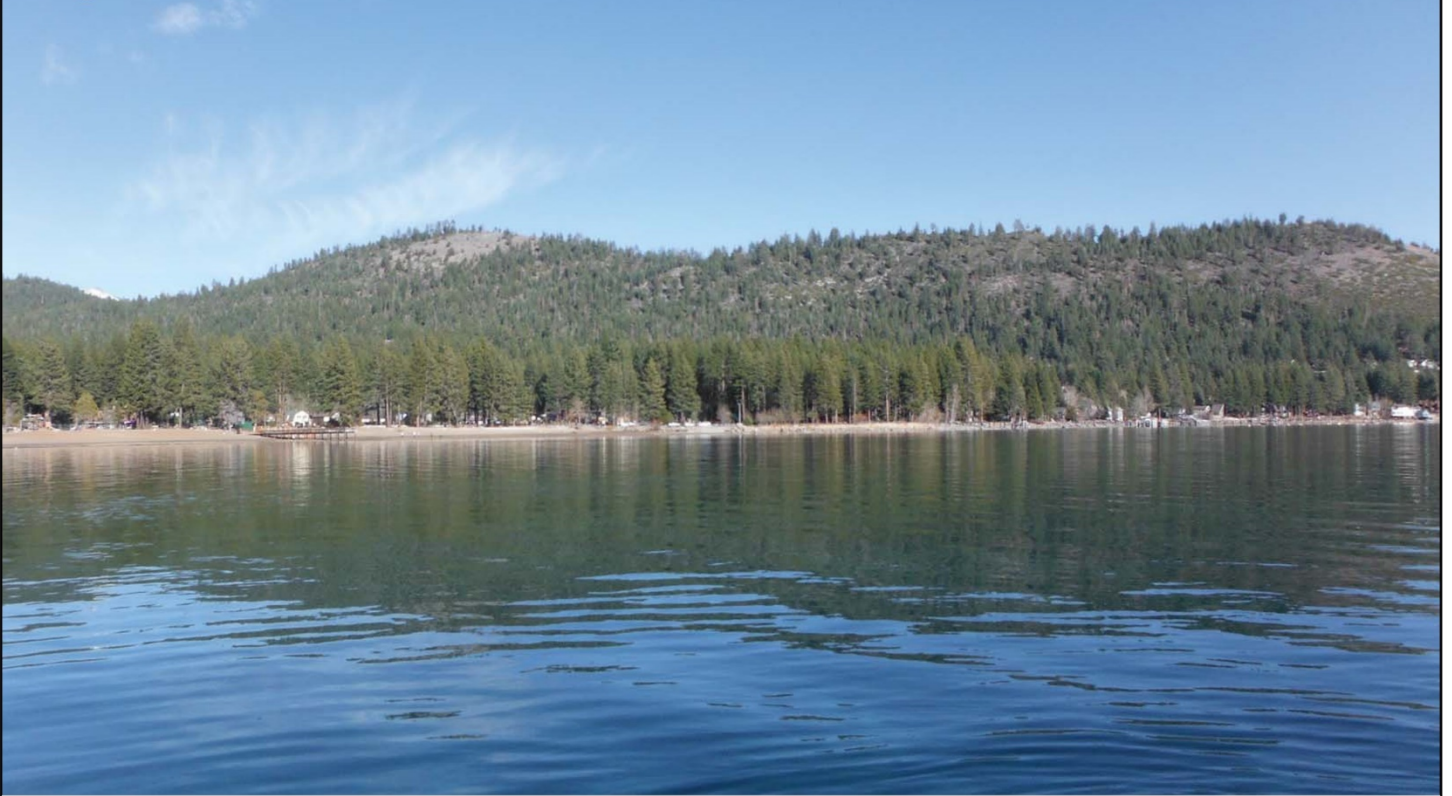
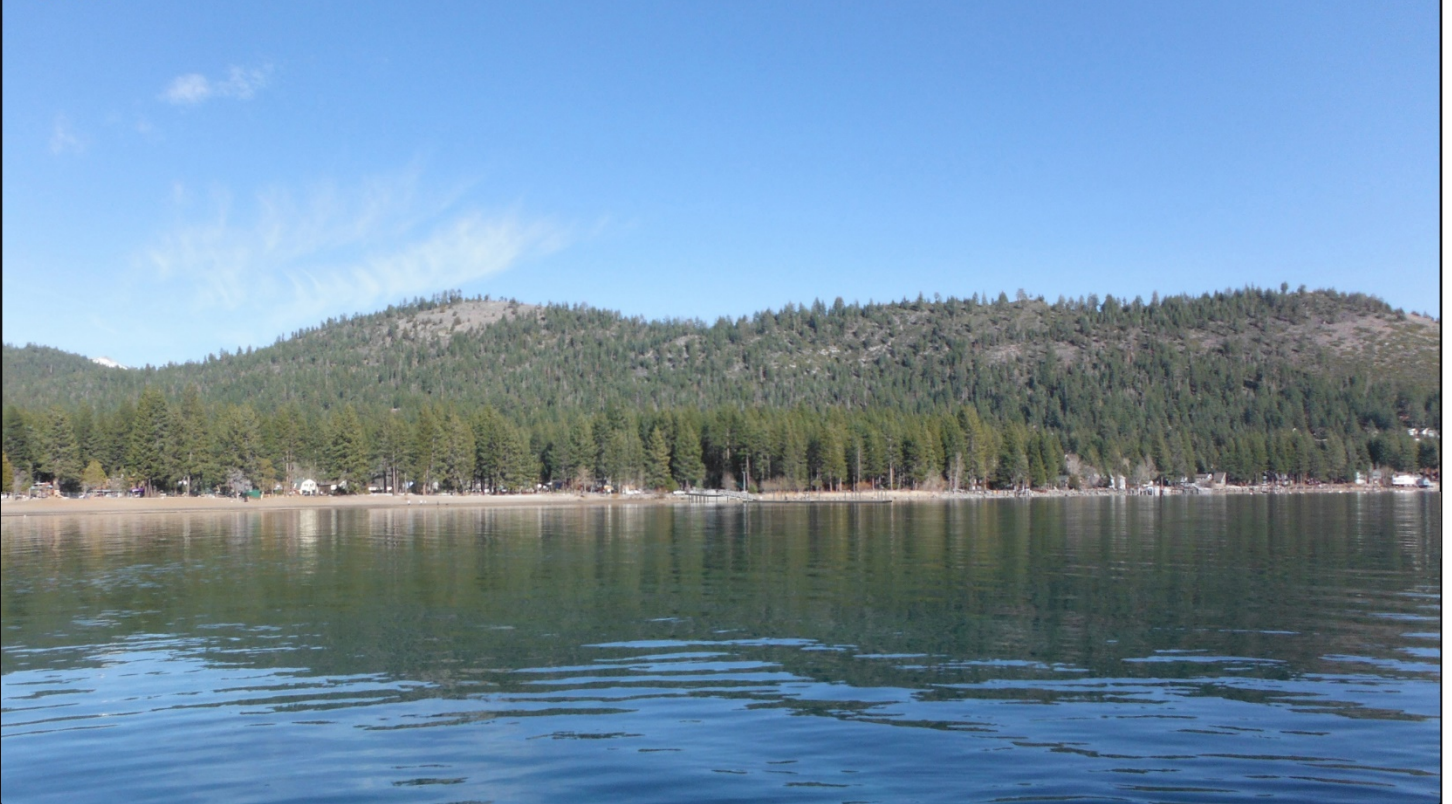
Exhibit 5.3.12-11 Existing View and Simulation of Alternative 2 from Viewpoint 8

Existing

Proposed

As shown in Exhibit 5.3.12-11, the proposed pier would be visible but would not dominate the view from this distance. The fixed portion of the pier and the gangway are the most visible elements of the pier because they block views of the sandy beach. The floating section of the pier, while longer and closer than the fixed portion, is substantially less prominent. The color and proximity of the floating section to the surface of the water cause it to blend into the water, while retaining unobstructed views of the sandy beach behind the pier. The design elements of the proposed pier are shown in greater detail in a rendering of the rebuilt pier included as Exhibit 5.3.12-12. Overall, Alternative 2 would result in the removal of an existing pier that blocks views of the sandy beach and replace it with a new pier that also blocks views of the sandy beach. The proposed pier would not change the character of the shoreline view, which already contains a mix of visible shoreline development and vegetation.

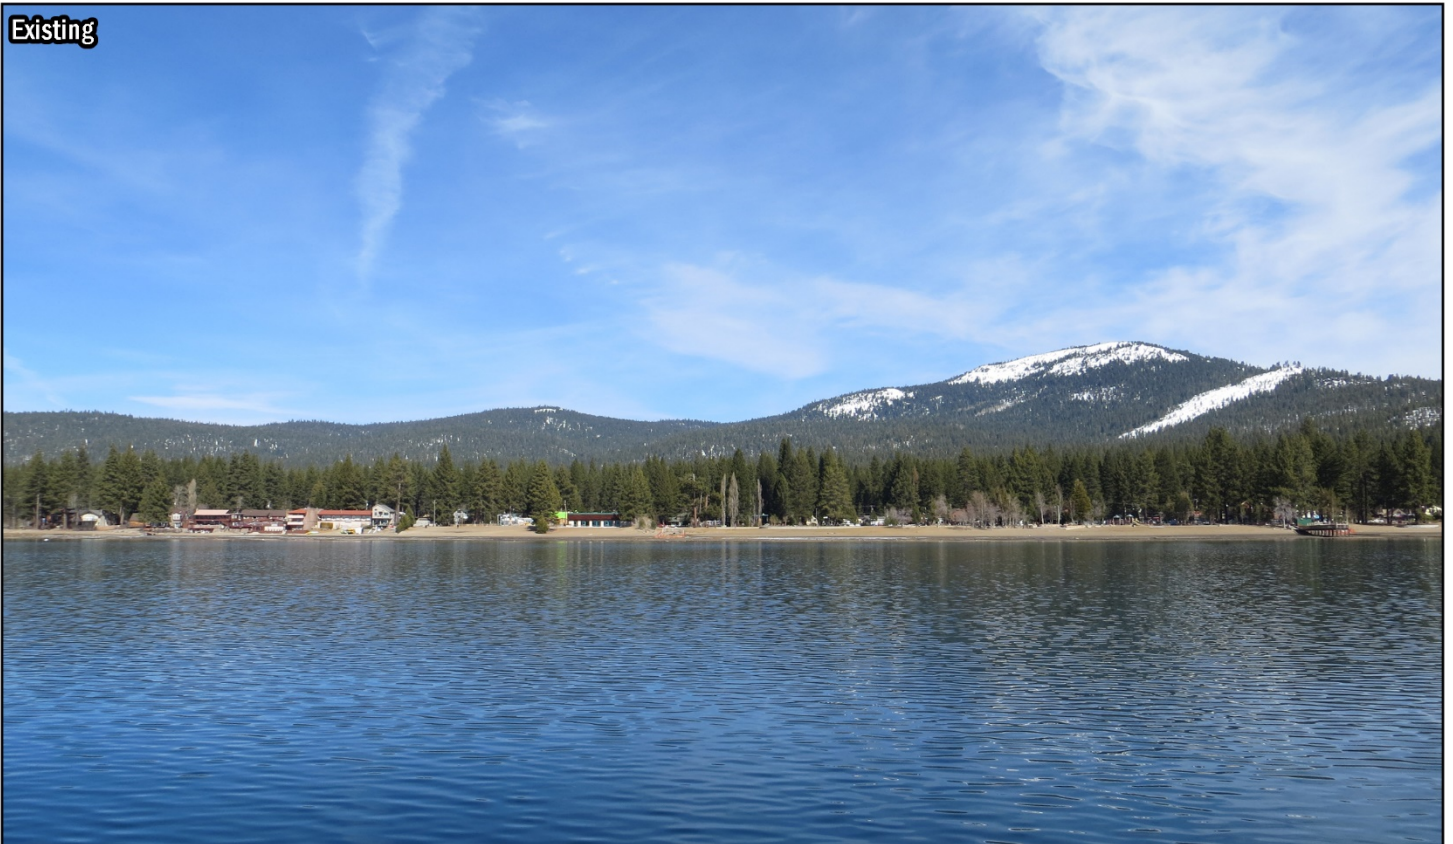
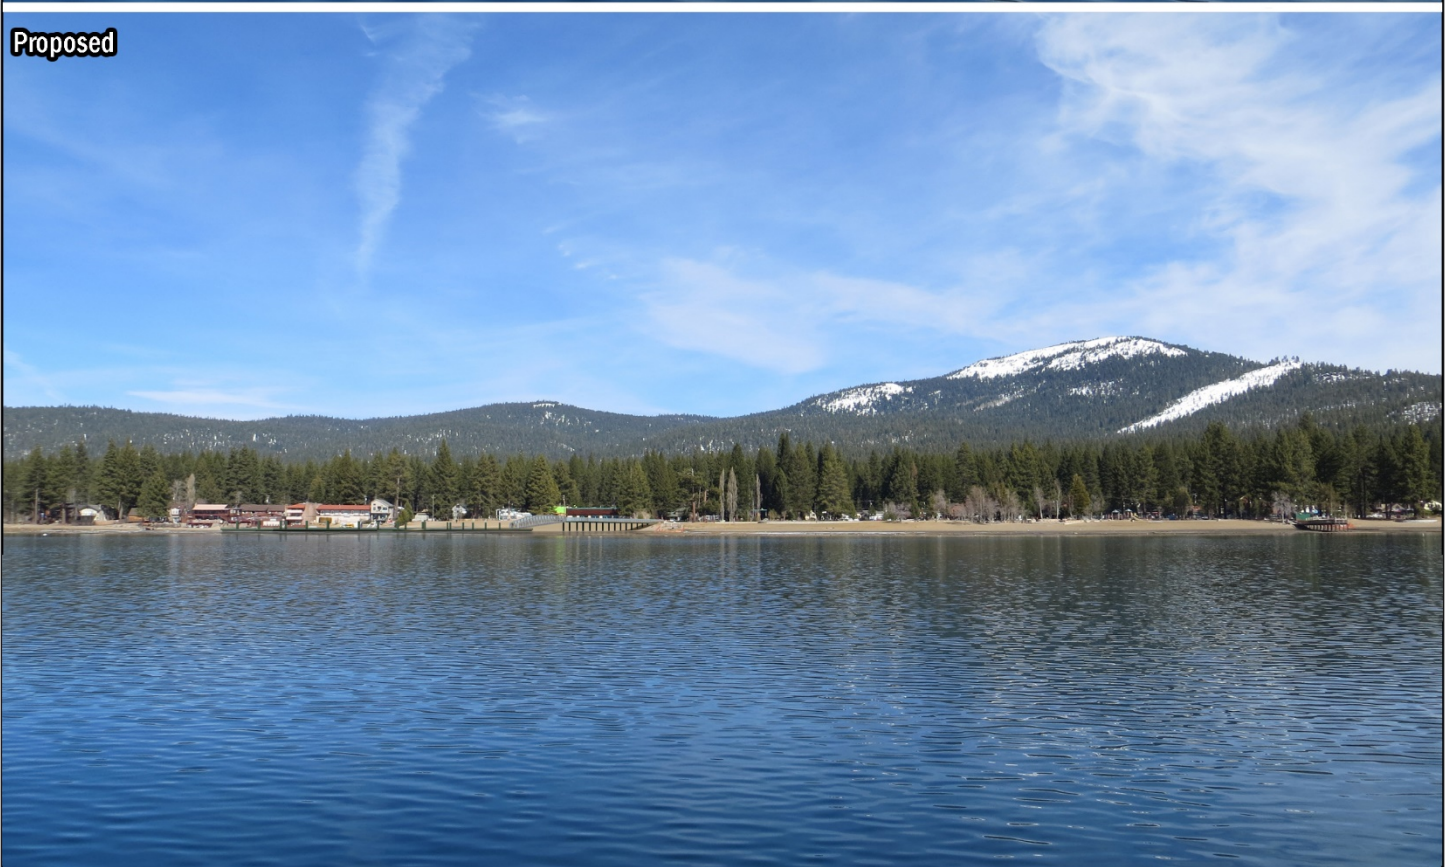
Exhibit 5.3.12-14 Existing View and Simulation of Alternative 4 from Viewpoint 10

Existing

Proposed

The visible mass of western pier proposed in Alternative 4 was calculated consistent with the approach included in Appendix D of the Kings Beach Pier Comparative Alternatives Analysis report (Conservancy 2016). Table 5.3.12-1, above, depicts the visible mass of the existing pier, and Table 5.3.12-5, below, shows the visible mass of the rebuilt pier proposed in Alternative 4, at a lake elevation of 6,226 LTD. No other removal or screening of visible mass would occur as part of the pier rebuild project under Alternative 4. As shown in these tables, the rebuilt pier proposed in Alternative 4 would result in an increase of 1,037.1 sq. ft. of visible mass. This increase in visible mass would be required to be offset through the removal or screening of existing visible mass pursuant to the requirements of the TRPA partial permitting program. Because Alternative 4 does not offset this increase in visible mass by removing or screening existing visible mass, this impact would be **significant**.
