Universal Trail Assessment Process (UTAP) & High Efficiency Trail Assessment Process (HETAP) Application & Dissemination

Applying the UTAP & HETAP Objectives

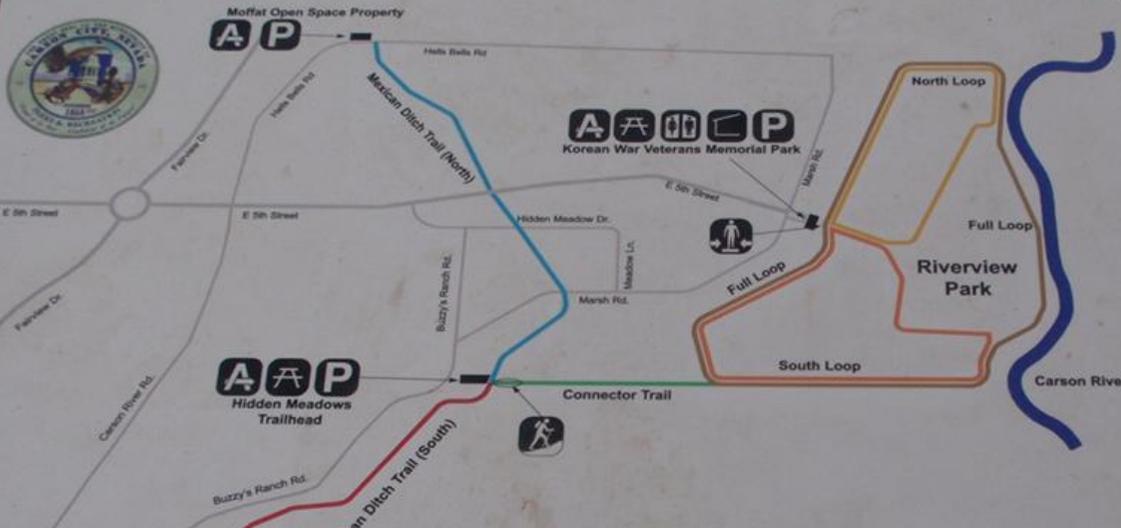
Riverview Park / Mexican Ditch Trail System

Trail Name	Length	Typical Grade	Max Grade	Typical Cross Slope	Max Cross Slope	Typical Trail Width	Min Clearance Width	Surface Type
Riverview Park (Full Loop)	1.6 mi	0.8%	90 ft is 8% - 11%	2.8%	722 ft is 6% - 10%	11ft	16 in	Aggregate / Gravel
Riverview Park (North Loop)	0.8 mi	0.8%	435 ft is 3% - 4%	2.5%	189 ft is 10%	10 ft	16 in	Aggregate / Gravel
Riverview Park (South Loop)	1.0 mi	0.8%	76 ft is 9%	2.5%	183 ft is 8%	12 ft	16 in	Aggregate / Gravel
Connector Trail	0.3 mi	2.2%	155 ft is 11%	2.0%	29 ft is 9%	12 ft	60 in	Aggregate / Gravel
Mexican Ditch Trail (North)	0.6 mi	0.8%	12 ft is 7% - 18%	5.0%	286 ft is 33%	12 ft	60 in	Aggregate / Gravel
Mexican Ditch Trail (South)	0.6 mi	0.7%	74 ft is 3%	2.5%	212 ft is 10%	8 ft	60 in	Sand

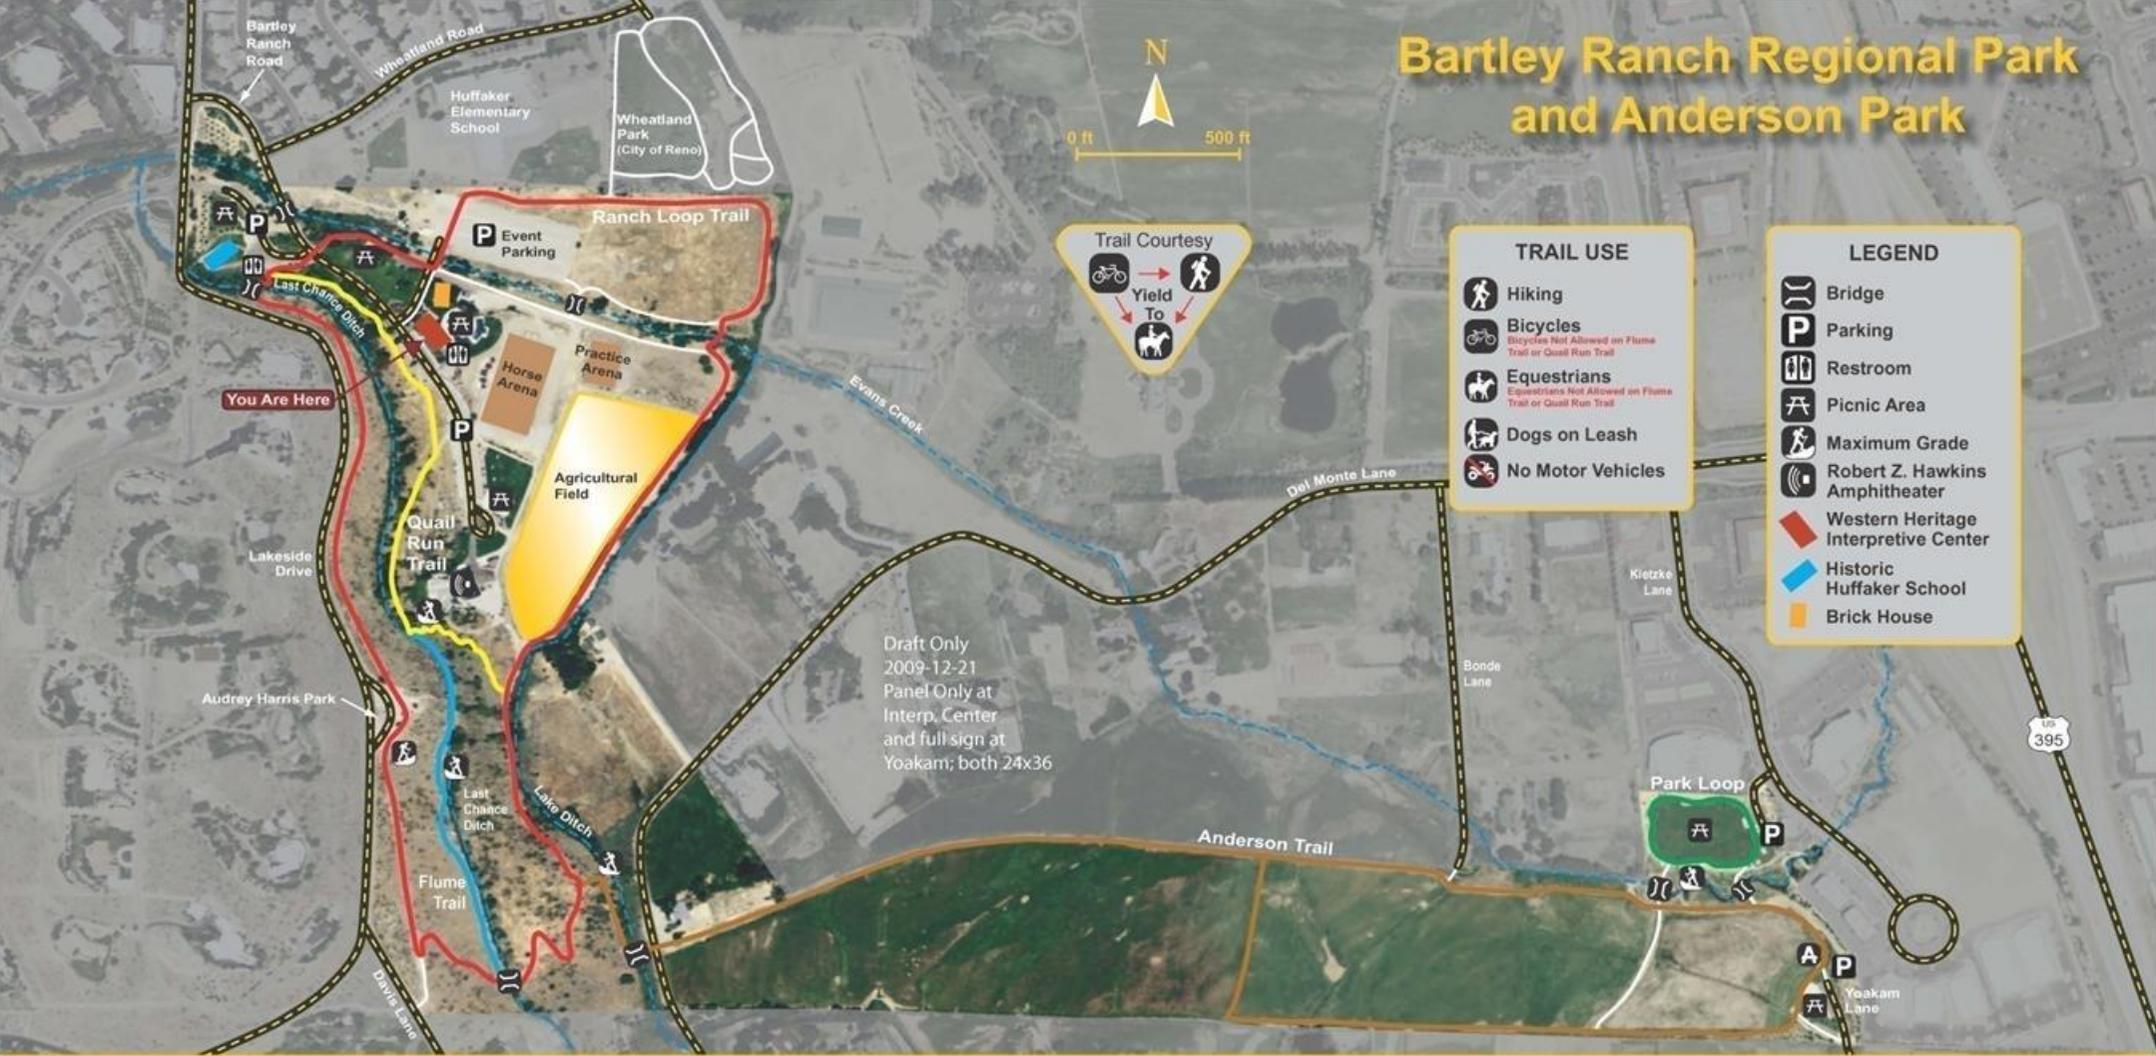
Bartley Ranch Regional Park and Anderson Park

Trail Name	Length	Typical Grade	Maximum Grade	Typical Cross Slope	Maximum Cross Slope	Typical Trail Width	Minimum Clearance Width	Surface Type	Surface Firmness		Surface Stability	
									Typical	Worst	Typical	Worst
Ranch Loop Trail	1.5 mi	4.5%	371 ft is 16% – 25%	2.8%	18 ft is 16% – 20%	90 in	40 in	Aggregate/Gravel	0.19	0.22	0.36	0.60
Quail Run Trail	0.4 mi	7.3%	186 ft is 20% – 40%	3.5%	46 ft is 18% – 30%	60 in	25 in	Aggregate/Gravel	0.19	0.22	0.39	0.50
Flume Trail	0.2 mi	4.6%	37 ft is 14% – 19%	3.9%	47 ft is 12% – 14%	48 in	20 in	Soil	0.23	0.25	0.38	0.49
Anderson Trail (Round Trip)	1.7 mi	2.5%	196 ft is 14% – 21%	2.4%	311 ft is 7% – 11%	76 in	48 in	Aggregate/Gravel	0.19	0.22	0.39	0.52
Park Loop	0.2 mi	1.6%	64 ft is 4% – 5%	1.8%	230 ft is 3% – 4%	84 in	84 in	Aggregate/Gravel	0.18	0.19	0.37	0.43

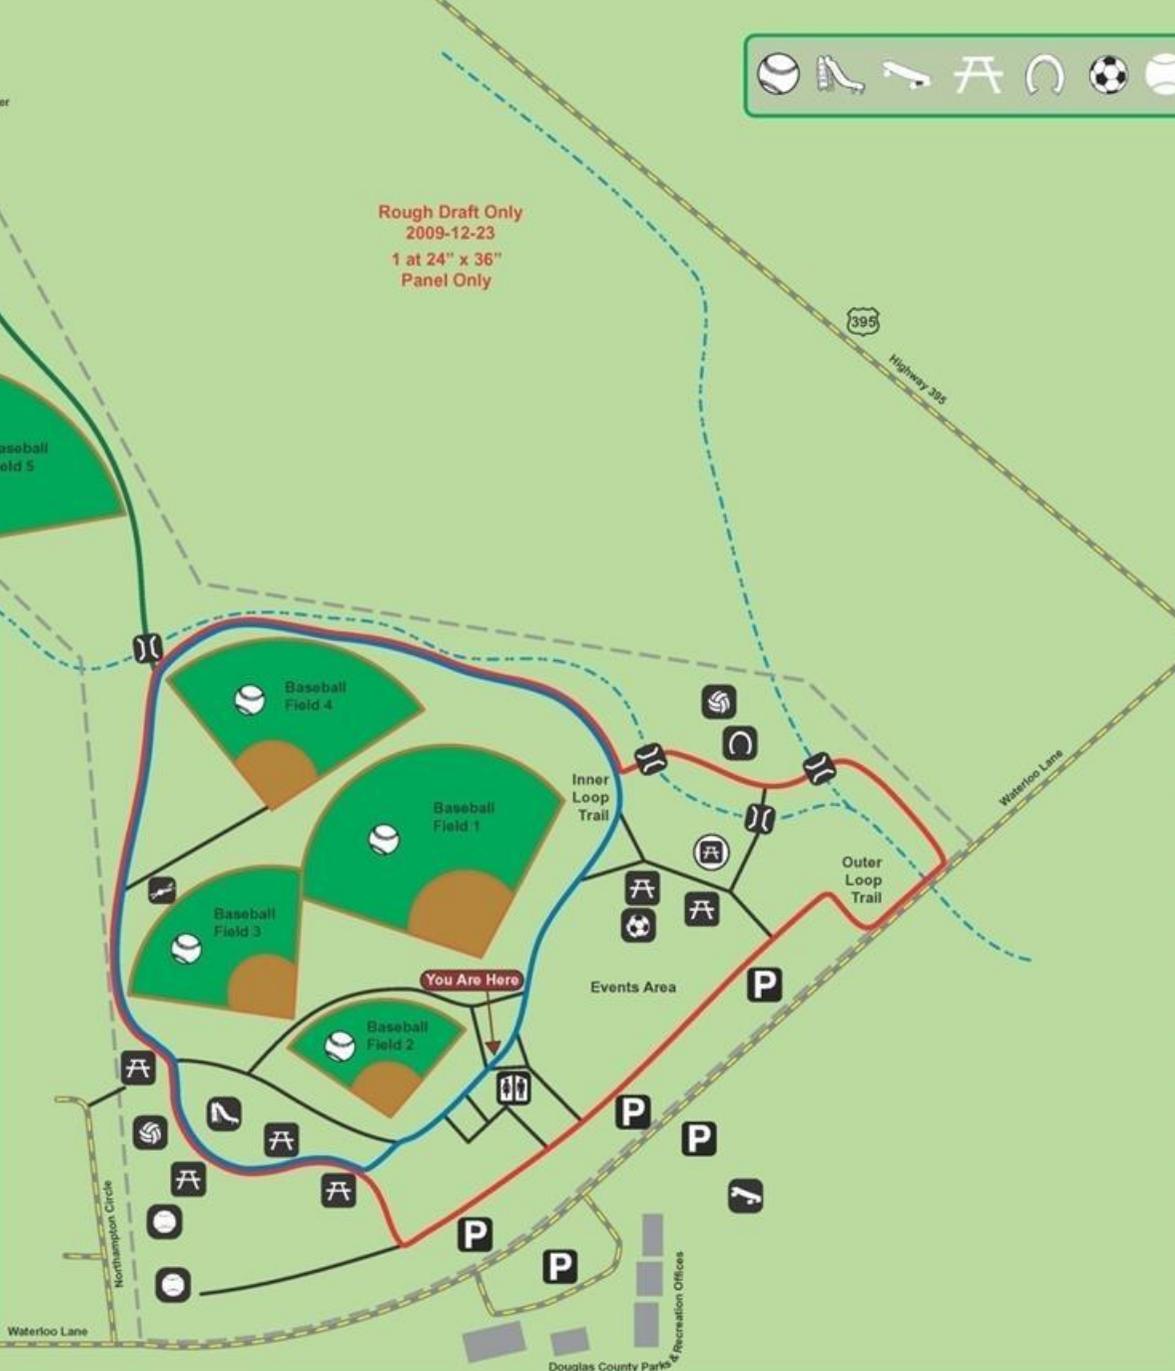
Lampe Park

Trail Name	Outer Loop Trail	Inner Loop Trail	Senior Center Trail
Length	0.8 miles	0.6 miles	0.2 miles
Typical Grade	1.3%	1.1%	1.5%
Maximum Grade	17 feet is 5 - 8%	41 feet is 3 - 5%	27 feet is 5 - 6%
Typical Cross Slope	1.5%	1.0%	1.1%
Maximum Cross Slope	142 feet is 5 - 6%	246 feet is 4 - 6%	63 feet is 3 - 5%
Typical Tread Width	10 feet	12 feet	9 feet
Minimum Clearance Width	49 inches	8 feet	7 feet
Surface Type	Decomposed Granite/Pavers	Decomposed Granite/Pavers	Decomposed Granite
Typical Surface Firmness	0.20 inches (Worst 0.23 inches)	0.20 inches (Worst 0.23 inches)	0.19 inches (Worst 0.23 inches)
Typical Surface Stability	0.26 inches (Worst 0.33 inches)	0.26 inches (Worst 0.33 inches)	0.28 inches (Worst 0.33 inches)

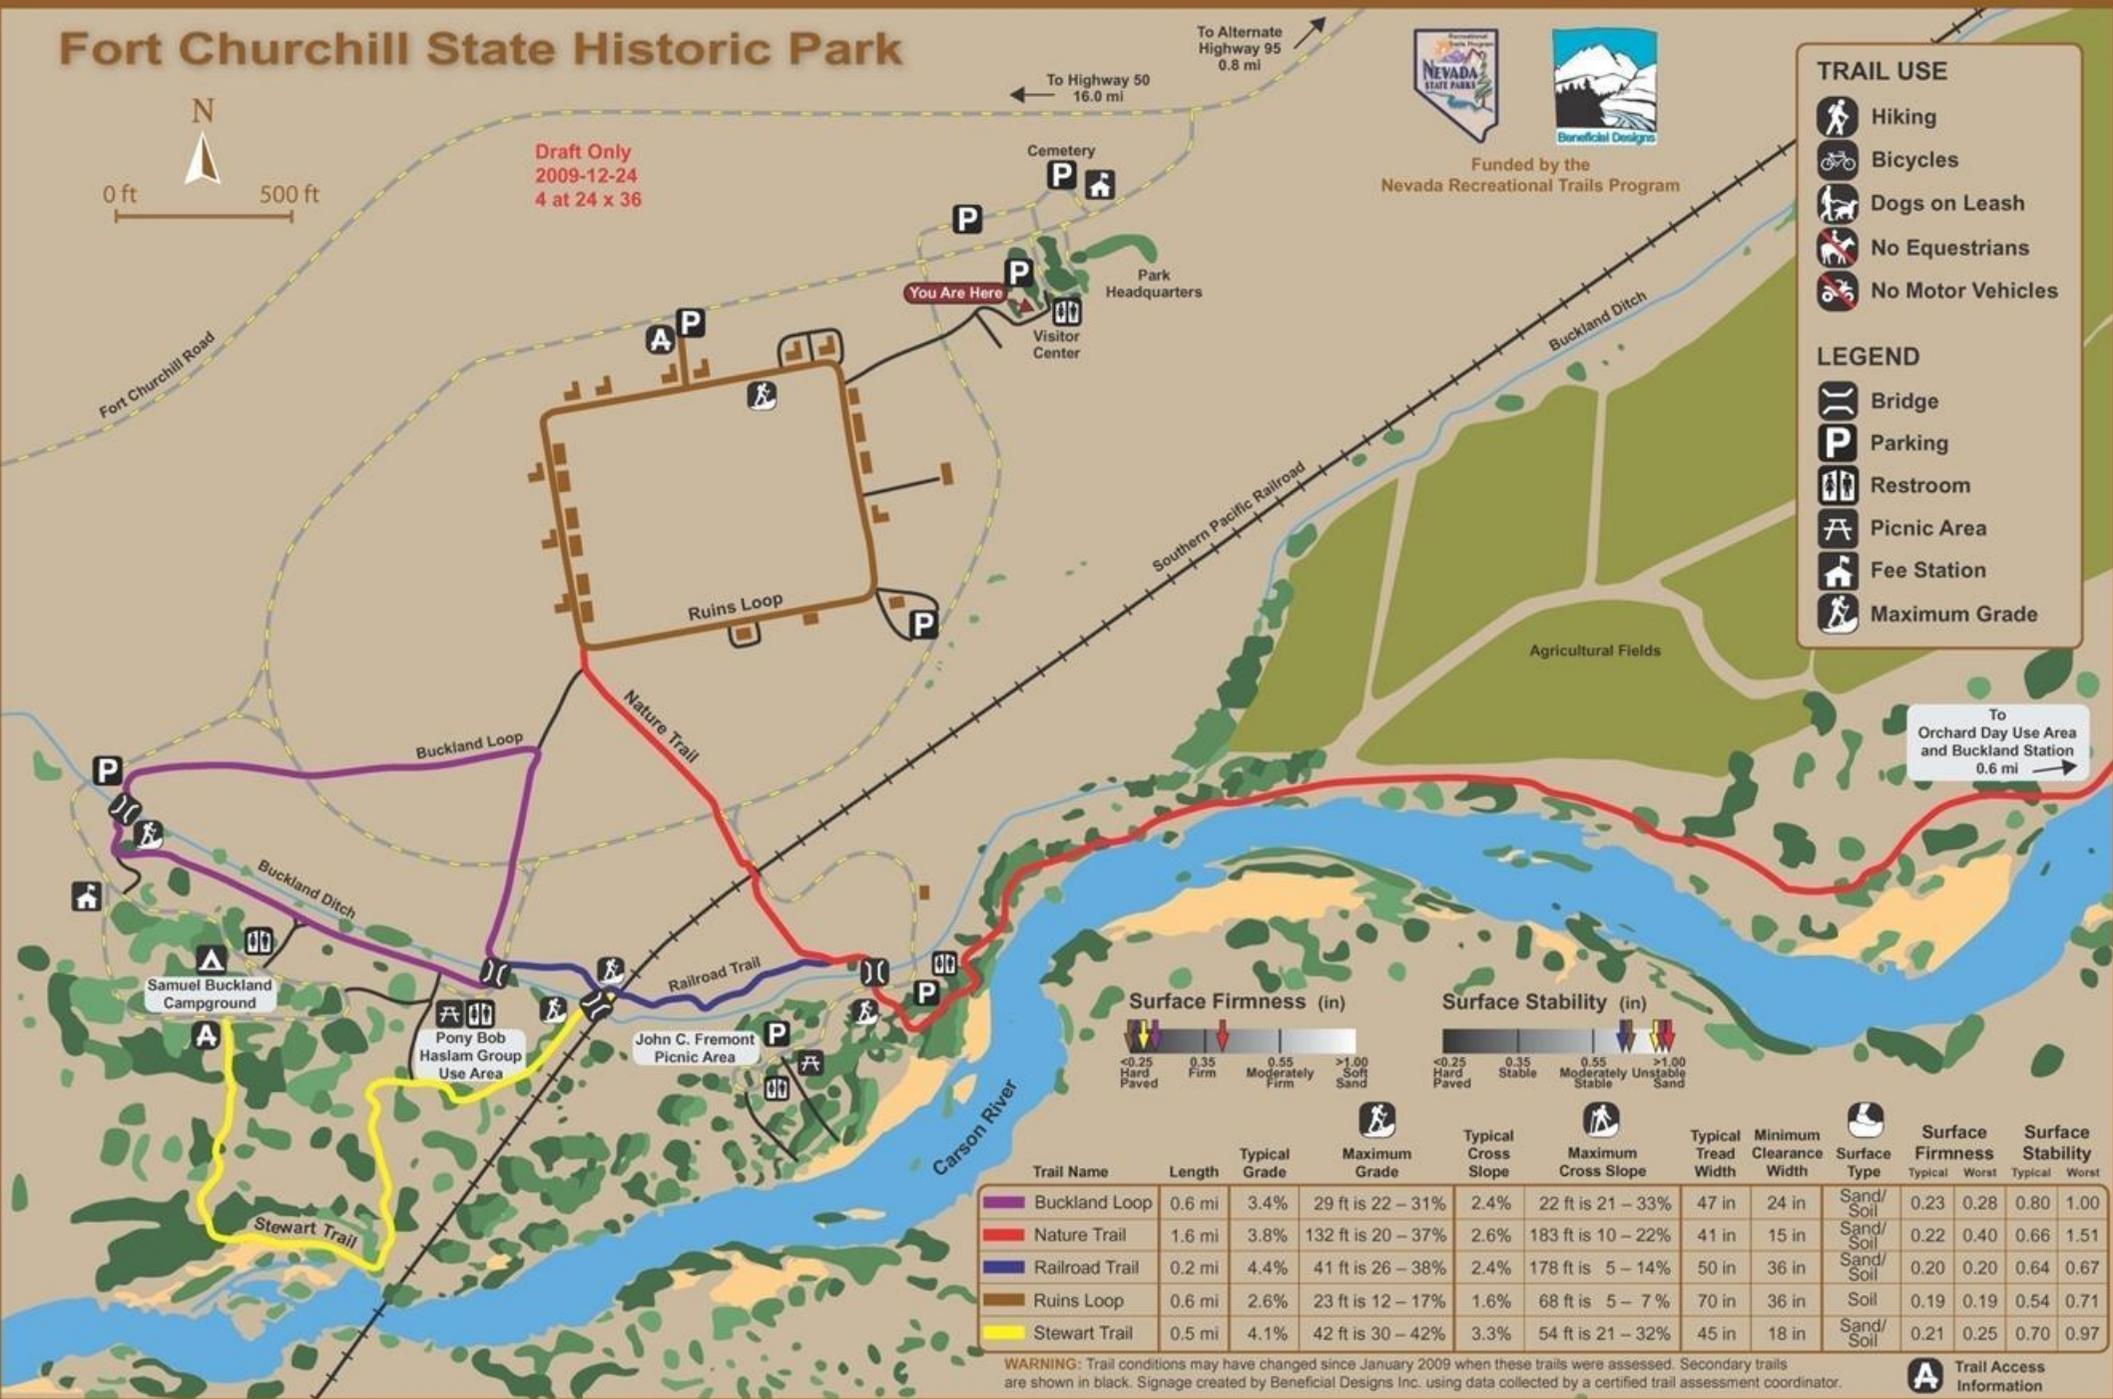
Trail Access Information

Trail Name	Length	Typical Grade	Maximum Grade	Typical Cross Slope	Maximum Cross Slope	Typical Tread Width	Minimum Clearance Width	Surface Type	Surface Firmness		Surface Stability	
									Typical	Worst	Typical	Worst
Buckland Loop	0.6 mi	3.4%	29 ft is 22 – 31%	2.4%	22 ft is 21 – 33%	47 in	24 in	Sand/Soil	0.23	0.28	0.80	1.00
Nature Trail	1.6 mi	3.8%	132 ft is 20 – 37%	2.6%	183 ft is 10 – 22%	41 in	15 in	Sand/Soil	0.22	0.40	0.66	1.51
Railroad Trail	0.2 mi	4.4%	41 ft is 26 – 38%	2.4%	178 ft is 5 – 14%	50 in	36 in	Sand/Soil	0.20	0.20	0.64	0.67
Ruins Loop	0.6 mi	2.6%	23 ft is 12 – 17%	1.6%	68 ft is 5 – 7%	70 in	36 in	Soil	0.19	0.19	0.54	0.71
Stewart Trail	0.5 mi	4.1%	42 ft is 30 – 42%	3.3%	54 ft is 21 – 32%	45 in	18 in	Sand/Soil	0.21	0.25	0.70	0.97
